Access Compliance Report

Public Rights-of-Way

(Island Curb Cuts)

Intersection ID: 5967	Main Street: N_TRYON_ST	Cross Street: MCCULLOUGH_DR	Location: SW
ADA ID: 8F9CBE9795EB	Curb Cut Type: MedianRefuge2	Initial Pass/Fail: Pass	Overall Compliance: No
Severity Score: 15			
Codes/Mitigation Info/Possible Solution		Field Measurements/Component Compliance

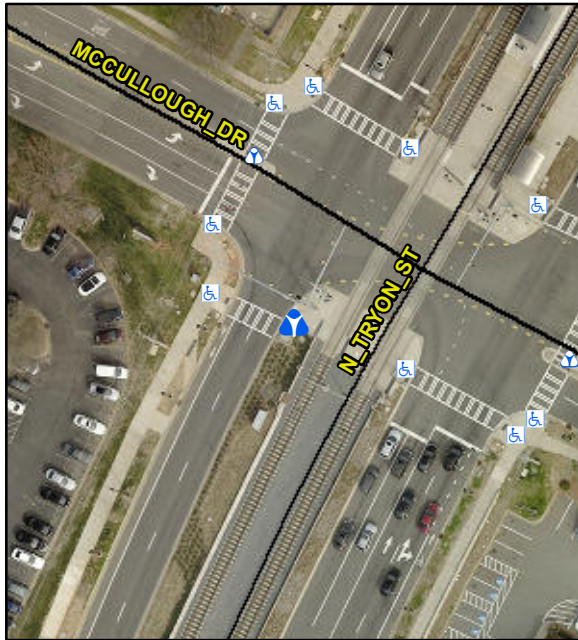
Compliance	Description	Data	Compliance	Description	Data
Yes	Refuge 1 Length (In)	116.5	No	Gutter 1 Ponding?	Yes
Yes	Refuge 1 Width (In)	235.0	No	Gutter 1 Lip Ht (In)	1.0
Yes	Refuge 1 Slope (%)	1.4	Yes	Gutter 1 Slope (%)	3.4
Yes	Refuge 1 X Slope (%)	0.2	Yes	Gutter 1 X Slope (%)	1.2
N/A	Painted X Walk1?	No	Yes	DWS 1 Provided?	Yes
N/A	X Walk 1 Direction	To NW	Yes	DWS 1 Contrast?	Yes
N/A	X Walk 1 Width (In)	N/A	Yes	DWS 1 Length (In)	24.0
N/A	Road 1 Slope (%)	1.0	Yes	DWS 1 Full Width?	Yes
N/A	Road 1 X Slope (%)	0.9	No	DWS 1 Offset (In)	5.0
Yes	Refuge 2 Length (In)	102.0	Yes	Gutter 2 Ponding?	No
Yes	Refuge 2 Width (In)	113.0	No	Gutter 2 Lip Ht (In)	N/A
Yes	Refuge 2 Slope (%)	1.2	Yes	Gutter 2 Slope (%)	3.4
Yes	Refuge 2 X Slope (%)	0.7	Yes	Gutter 2 X Slope (%)	1.2
N/A	Painted X Walk2?	No	Yes	DWS 2 Provided?	Yes
N/A	X Walk 2 Direction	To SE	Yes	DWS 2 Contrast?	Yes
N/A	X Walk 2 Width (In)	N/A	Yes	DWS 2 Length (In)	24.0

N/A	Road 2 Slope (%)	N/A	Yes	DWS 2 Full Width?	Yes
N/A	Road 2 X Slope (%)	N/A	Yes	DWS 2 Offset (In)	0.0
N/A	Refuge 3 Length (in)	N/A	N/A	Gutter 3 Ponding?	No
N/A	Refuge 3 Width (in)	N/A	N/A	Gutter 3 Lip Ht (in)	N/A
N/A	Refuge 3 Slope (%)	N/A	N/A	Gutter 3 Slope (%)	N/A
N/A	Refuge 3 XSlope (%)	N/A	N/A	Gutter 3 XSlope (%)	N/A
N/A	Painted X Walk3?	No	N/A	DWS 3 Provided?	N/A
N/A	X Walk 3 Direction	N/A	N/A	DWS 3 Contrast?	N/A
N/A	X Walk 3 Width (in)	N/A	N/A	DWS 3 Length (in)	N/A
N/A	Road 3 Slope (%)	N/A	N/A	DWS 3 Full Width?	N/A
N/A	Road 3 XSlope (%)	N/A	N/A	DWS 3 Offset (in)	N/A
Yes	Any Obstructions?	No	N/A	Storm Grate/Utility Hazard?	No
N/A	Obstruction Type		N/A	Storm Grate/Utility Type	
		N/A			N/A
N/A	Surface Condition	Good

Possible Solutions:

Remove & Replace Detectable Warning System. Grind Gutter Lip.
