Access Compliance Report

Public Rights-of-Way

(Island Curb Cuts)

Intersection ID: 27397	Main Street: ELM_LN	Cross Street: BALLANTYNE_COMMONS_PY	Location: N
ADA ID: 8FAA072A5C9D	Curb Cut Type: MedianRefuge2	Initial Pass/Fail: Fail	Overall Compliance: No
		Severity Score: 0

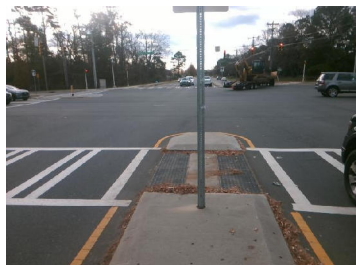
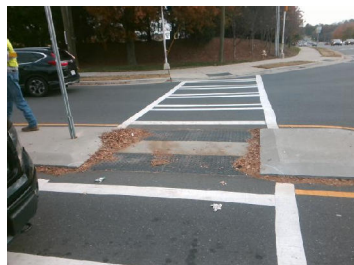
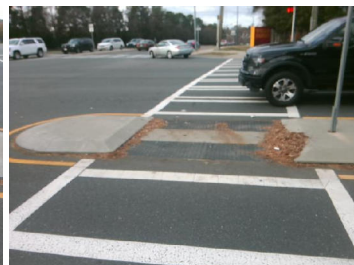
Compliance	Description	Data	Compliance	Description	Data
No	Refuge 1 Length (In)	35.5	N/A	Gutter 1 Ponding?	N/A
Yes	Refuge 1 Width (In)	98.0	N/A	Gutter 1 Lip Ht (In)	N/A
Yes	Refuge 1 Slope (%)	1.3	N/A	Gutter 1 Slope (%)	N/A
Yes	Refuge 1 X Slope (%)	2.4	N/A	Gutter 1 X Slope (%)	N/A
N/A	Painted X Walk1?	Yes	N/A	DWS 1 Provided?	N/A
N/A	X Walk 1 Direction	To NE	N/A	DWS 1 Contrast?	N/A
N/A	X Walk 1 Width (In)	111.0	N/A	DWS 1 Length (In)	N/A
N/A	Road 1 Slope (%)	1.3	N/A	DWS 1 Full Width?	N/A
N/A	Road 1 X Slope (%)	0.5	N/A	DWS 1 Offset (In)	N/A
No	Refuge 2 Length (In)	35.5	N/A	Gutter 2 Ponding?	N/A
Yes	Refuge 2 Width (In)	98.0	N/A	Gutter 2 Lip Ht (In)	N/A
Yes	Refuge 2 Slope (%)	0.6	N/A	Gutter 2 Slope (%)	N/A
Yes	Refuge 2 X Slope (%)	2.8	N/A	Gutter 2 X Slope (%)	N/A
N/A	Painted X Walk2?	Yes	N/A	DWS 2 Provided?	N/A
N/A	X Walk 2 Direction	To SW	N/A	DWS 2 Contrast?	N/A
N/A	X Walk 2 Width (In)	108.0	N/A	DWS 2 Length (In)	N/A

N/A	Road 2 Slope (%)	0.6	N/A	DWS 2 Full Width?	N/A
N/A	Road 2 X Slope (%)	2.8	N/A	DWS 2 Offset (In)	N/A
N/A	Refuge 3 Length (in)	N/A	N/A	Gutter 3 Ponding?	N/A
N/A	Refuge 3 Width (in)	N/A	N/A	Gutter 3 Lip Ht (in)	N/A
N/A	Refuge 3 Slope (%)	N/A	N/A	Gutter 3 Slope (%)	N/A
N/A	Refuge 3 XSlope (%)	N/A	N/A	Gutter 3 XSlope (%)	N/A
N/A	Painted X Walk3?	N/A	N/A	DWS 3 Provided?	N/A
N/A	X Walk 3 Direction	N/A	N/A	DWS 3 Contrast?	N/A
N/A	X Walk 3 Width (in)	N/A	N/A	DWS 3 Length (in)	N/A
N/A	Road 3 Slope (%)	N/A	N/A	DWS 3 Full Width?	N/A
N/A	Road 3 XSlope (%)	N/A	N/A	DWS 3 Offset (in)	N/A
Yes	Any Obstructions?	N/A	N/A	Storm Grate/Utility Hazard?	N/A
N/A	Obstruction Type		N/A	Storm Grate/Utility Type	
		N/A			N/A
N/A	Surface Condition	Good

Remove & Replace Entire Refuge.

\$ 3000.00
