# Access Compliance Report

## Public Rights-of-Way

### (Island Curb Cuts)

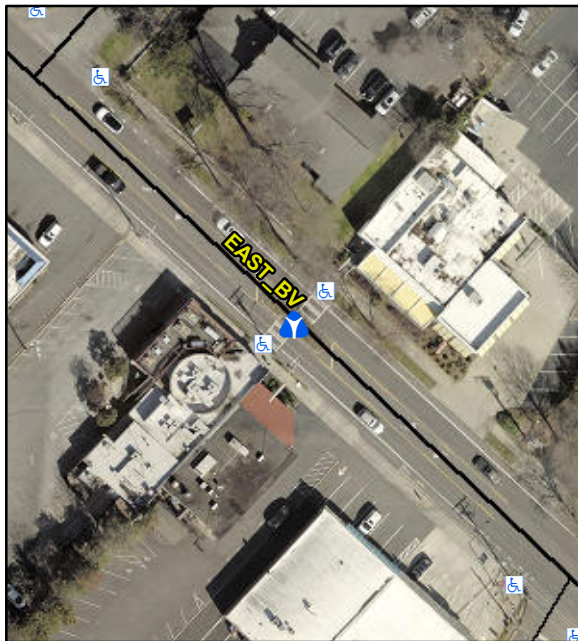
Intersection ID: 10025677	Main Street: EAST_BV	Cross Street: N/A	Location: N
ADA ID: 8FC6222EF554	Curb Cut Type: MedianRefuge2	Initial Pass/Fail: Fail	Overall Compliance: No
Severity Score: 1.25			
Codes/Mitigation Info/Possible Solution		Field Measurements/Component Compliance

**Remove & Replace Entire Refuge.**
