Access Compliance Report

Public Rights-of-Way

(Island Curb Cuts)

Intersection ID: 15460	Main Street: CLANTON_RD	Cross Street: S_I-77_TO_CLANTON_RD_RA_SB	Location: NW
ADA ID: 904565E29219	Curb Cut Type: IslandRefuge3	Initial Pass/Fail: Fail	Overall Compliance: No
Severity Score: 36.25			
Codes/Mitigation Info/Possible Solution		Field Measurements/Component Compliance

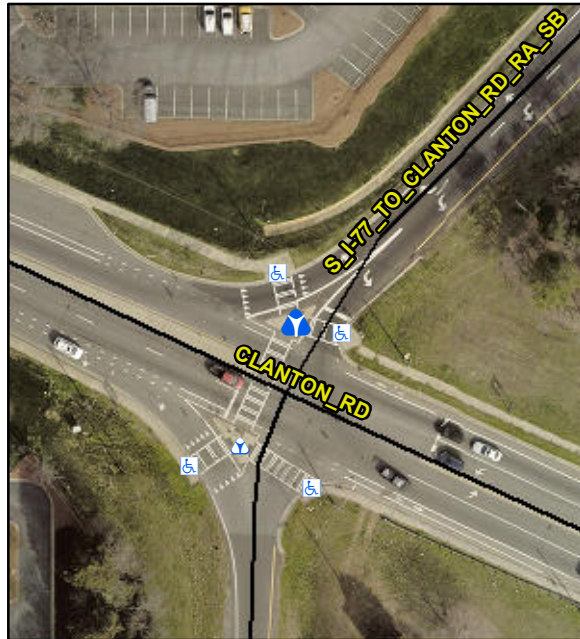
Compliance	Description	Data	Compliance	Description	Data
Yes	Refuge 1 Length (In)	56.0	N/A	Gutter 1 Ponding?	N/A
Yes	Refuge 1 Width (In)	60.0	N/A	Gutter 1 Lip Ht (In)	N/A
Yes	Refuge 1 Slope (%)	2.9	N/A	Gutter 1 Slope (%)	N/A
Yes	Refuge 1 X Slope (%)	0.8	N/A	Gutter 1 X Slope (%)	N/A
N/A	Painted X Walk1?	Yes	N/A	DWS 1 Provided?	N/A
N/A	X Walk 1 Direction	To N	N/A	DWS 1 Contrast?	N/A
N/A	X Walk 1 Width (In)	110.0	N/A	DWS 1 Length (In)	N/A
N/A	Road 1 Slope (%)	2.6	N/A	DWS 1 Full Width?	N/A
N/A	Road 1 X Slope (%)	0.3	N/A	DWS 1 Offset (In)	N/A
Yes	Refuge 2 Length (In)	61.0	N/A	Gutter 2 Ponding?	N/A
Yes	Refuge 2 Width (In)	60.0	N/A	Gutter 2 Lip Ht (In)	N/A
Yes	Refuge 2 Slope (%)	1.6	N/A	Gutter 2 Slope (%)	N/A
Yes	Refuge 2 X Slope (%)	0.9	N/A	Gutter 2 X Slope (%)	N/A
N/A	Painted X Walk2?	Yes	N/A	DWS 2 Provided?	N/A
N/A	X Walk 2 Direction	To SE	N/A	DWS 2 Contrast?	N/A
N/A	X Walk 2 Width (In)	110.0	N/A	DWS 2 Length (In)	N/A

N/A	Road 2 Slope (%)	2.4	N/A	DWS 2 Full Width?	N/A
N/A	Road 2 X Slope (%)	2.1	N/A	DWS 2 Offset (In)	N/A
Yes	Refuge 3 Length (in)	86.0	N/A	Gutter 3 Ponding?	N/A
Yes	Refuge 3 Width (in)	60.0	N/A	Gutter 3 Lip Ht (in)	N/A
Yes	Refuge 3 Slope (%)	2.6	N/A	Gutter 3 Slope (%)	N/A
Yes	Refuge 3 XSlope (%)	2.9	N/A	Gutter 3 XSlope (%)	N/A
N/A	Painted X Walk3?	Yes	N/A	DWS 3 Provided?	N/A
N/A	X Walk 3 Direction	To SW	N/A	DWS 3 Contrast?	N/A
N/A	X Walk 3 Width (in)	110.0	N/A	DWS 3 Length (in)	N/A
N/A	Road 3 Slope (%)	2.6	N/A	DWS 3 Full Width?	N/A
N/A	Road 3 XSlope (%)	1.8	N/A	DWS 3 Offset (in)	N/A
Yes	Any Obstructions?	N/A	N/A	Storm Grate/Utility Hazard?	N/A
N/A	Obstruction Type		N/A	Storm Grate/Utility Type	
N/A	Surface Condition	Good	N/A		N/A

Remove & Replace Entire Refuge.
