Access Compliance Report

Public Rights-of-Way

(Island Curb Cuts)

Intersection ID: 7486	Main Street: N_TRYON_ST	Cross Street: OWEN_BV	Location:	S
ADA ID: 913FFD6D46A7	Curb Cut Type: MedianRefuge2	Initial Pass/Fail: Pass	Overall Compliance: No	Severity Score: 0.25
Codes/Mitigation Info/Possible Solution		Field Measurements/Component Compliance

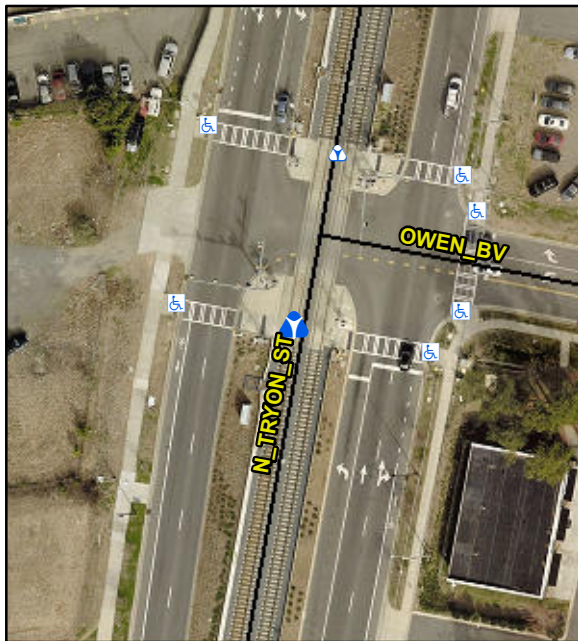
N/A	Road 2 Slope (%)	0.7	Yes	DWS 2 Full Width?	Yes
N/A	Road 2 X Slope (%)	0.3	No	DWS 2 Offset (In)	50.0
N/A	Refuge 3 Length (in)	N/A	N/A	Gutter 3 Ponding?	N/A
N/A	Refuge 3 Width (in)	N/A	N/A	Gutter 3 Lip Ht (in)	N/A
N/A	Refuge 3 Slope (%)	N/A	N/A	Gutter 3 Slope (%)	N/A
N/A	Refuge 3 XSlope (%)	N/A	N/A	Gutter 3 XSlope (%)	N/A
N/A	Painted X Walk3?	N/A	N/A	DWS 3 Provided?	N/A
N/A	X Walk 3 Direction	N/A	N/A	DWS 3 Contrast?	N/A
N/A	X Walk 3 Width (in)	N/A	N/A	DWS 3 Length (in)	N/A
N/A	Road 3 Slope (%)	N/A	N/A	DWS 3 Full Width?	N/A
N/A	Road 3 XSlope (%)	N/A	N/A	DWS 3 Offset (in)	N/A
Yes	Any Obstructions?	N/A	N/A	Storm Grate/Utility Hazard?	No
N/A	Obstruction Type		N/A	Storm Grate/Utility Type	
		N/A			N/A
N/A	Surface Condition	Good

Remove & Replace Detectable Warning System.
