Access Compliance Report

Public Rights-of-Way

(Island Curb Cuts)

Intersection ID: 44555	Main Street: UNIVERSITY_CITY_BV	Cross Street: N_TRYON_ST	Location: SE
ADA ID: 91F4A1006D08	Curb Cut Type: IslandRefuge3	Initial Pass/Fail: Pass	Overall Compliance: No
Codes/Mitigation Info/Possible Solution		Field Measurements/Component Compliance

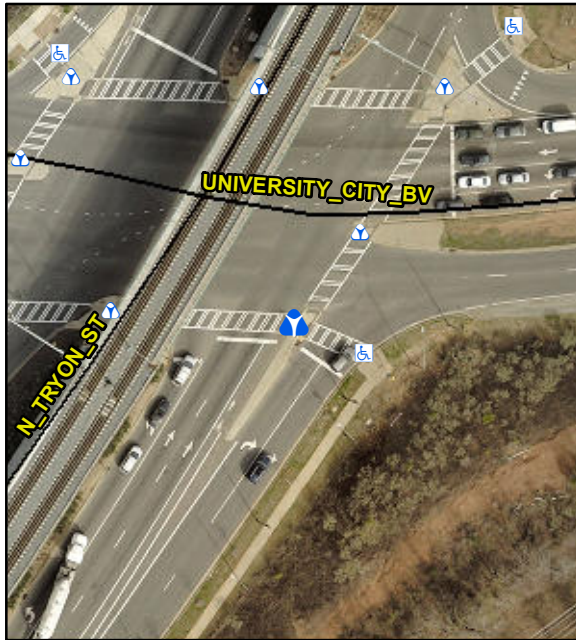
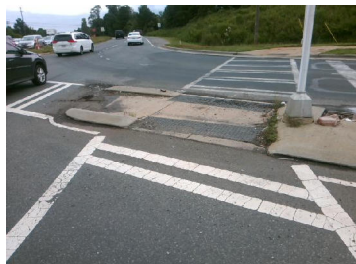
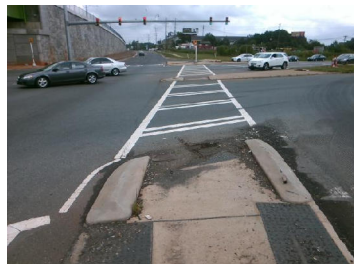
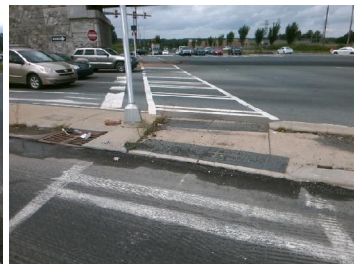
Compliance	Description	Data	Compliance	Description	Data
Yes	Refuge 1 Length (In)	19.5	No	Gutter 1 Ponding?	Yes
Yes	Refuge 1 Width (In)	95.0	Yes	Gutter 1 Lip Ht (In)	0.0
Yes	Refuge 1 Slope (%)	2.3	Yes	Gutter 1 Slope (%)	2.8
Yes	Refuge 1 X Slope (%)	0.1	Yes	Gutter 1 X Slope (%)	1.4
N/A	Painted X Walk1?	Yes	Yes	DWS 1 Provided?	Yes
N/A	X Walk 1 Direction	To W	Yes	DWS 1 Contrast?	Yes
N/A	X Walk 1 Width (In)	115.0	Yes	DWS 1 Length (In)	24.0
N/A	Road 1 Slope (%)	0.1	Yes	DWS 1 Full Width?	Yes
N/A	Road 1 X Slope (%)	2.3	No	DWS 1 Offset (In)	7.0
Yes	Refuge 2 Length (In)	77.0	No	Gutter 2 Ponding?	Yes
Yes	Refuge 2 Width (In)	95.0	Yes	Gutter 2 Lip Ht (In)	0.0
Yes	Refuge 2 Slope (%)	1.9	Yes	Gutter 2 Slope (%)	2.5
Yes	Refuge 2 X Slope (%)	1.5	Yes	Gutter 2 X Slope (%)	0.6
N/A	Painted X Walk2?	Yes	Yes	DWS 2 Provided?	Yes
N/A	X Walk 2 Direction	To N	Yes	DWS 2 Contrast?	Yes
N/A	X Walk 2 Width (In)	118.0	Yes	DWS 2 Length (In)	24.0

N/A	Road 2 Slope (%)	1.8	Yes	DWS 2 Full Width?	Yes
N/A	Road 2 X Slope (%)	2.0	Yes	DWS 2 Offset (In)	0.0
Yes	Refuge 3 Length (in)	15.0	No	Gutter 3 Ponding?	Yes
Yes	Refuge 3 Width (in)	71.0	No	Gutter 3 Lip Ht (in)	1.5
Yes	Refuge 3 Slope (%)	2.9	Yes	Gutter 3 Slope (%)	0.4
Yes	Refuge 3 XSlope (%)	0.0	Yes	Gutter 3 XSlope (%)	1.0
N/A	Painted X Walk3?	Yes	Yes	DWS 3 Provided?	Yes
N/A	X Walk 3 Direction	To SE	Yes	DWS 3 Contrast?	Yes
N/A	X Walk 3 Width (in)	118.0	Yes	DWS 3 Length (in)	24.0
N/A	Road 3 Slope (%)	0.0	No	DWS 3 Full Width?	No
N/A	Road 3 XSlope (%)	0.6	Yes	DWS 3 Offset (in)	0.0
Yes	Any Obstructions?	No	N/A	Storm Grate/Utility Hazard?	No
N/A	Obstruction Type	N/A	N/A	Storm Grate/Utility Type	N/A
N/A	Surface Condition	Good

Remove & Replace Detectable Warning System. Fix Gutter Ponding. Grind Gutter Lip.
