Access Compliance Report

Public Rights-of-Way

(Island Curb Cuts)

Intersection ID: 7091	Main Street: BROOKSHIRE_BV	Cross Street: HOVIS_RD	Location:	N/A
ADA ID: 927E235B0EBA	Curb Cut Type: MedianRefuge2	Initial Pass/Fail: Fail	Overall Compliance: No	Severity Score: 0
Codes/Mitigation Info/Possible Solution		Field Measurements/Component Compliance

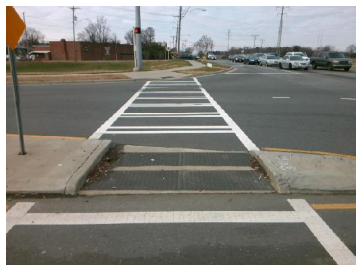
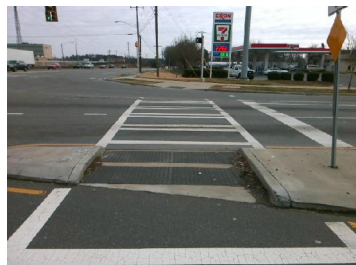
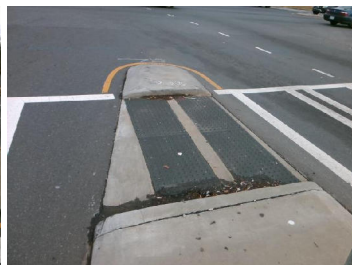
Compliance	Description	Data	Compliance	Description	Data
No	Refuge 1 Length (In)	29.0	N/A	Gutter 1 Ponding?	N/A
Yes	Refuge 1 Width (In)	96.0	N/A	Gutter 1 Lip Ht (In)	N/A
Yes	Refuge 1 Slope (%)	1.7	N/A	Gutter 1 Slope (%)	N/A
Yes	Refuge 1 X Slope (%)	2.5	N/A	Gutter 1 X Slope (%)	N/A
N/A	Painted X Walk1?	Yes	N/A	DWS 1 Provided?	N/A
N/A	X Walk 1 Direction	To SE	N/A	DWS 1 Contrast?	N/A
N/A	X Walk 1 Width (In)	112.0	N/A	DWS 1 Length (In)	N/A
N/A	Road 1 Slope (%)	2.1	N/A	DWS 1 Full Width?	N/A
N/A	Road 1 X Slope (%)	0.3	N/A	DWS 1 Offset (In)	N/A
No	Refuge 2 Length (In)	29.0	N/A	Gutter 2 Ponding?	N/A
Yes	Refuge 2 Width (In)	96.0	N/A	Gutter 2 Lip Ht (In)	N/A
Yes	Refuge 2 Slope (%)	1.1	N/A	Gutter 2 Slope (%)	N/A
Yes	Refuge 2 X Slope (%)	1.4	N/A	Gutter 2 X Slope (%)	N/A
N/A	Painted X Walk2?	Yes	N/A	DWS 2 Provided?	N/A
N/A	X Walk 2 Direction	To NW	N/A	DWS 2 Contrast?	N/A
N/A	X Walk 2 Width (In)	112.0	N/A	DWS 2 Length (In)	N/A

Remove & Replace Entire Refuge.
