Access Compliance Report

Public Rights-of-Way

(Island Curb Cuts)

Intersection ID: 25747	Main Street: HAMILTON_RD	Cross Street: SMITH_RD	Location: N
ADA ID: 9287162A5124	Curb Cut Type: MedianRefuge2	Initial Pass/Fail: Fail	Overall Compliance: No
Codes/Mitigation Info/Possible Solution		Field Measurements/Component Compliance

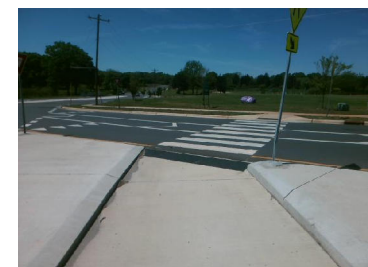
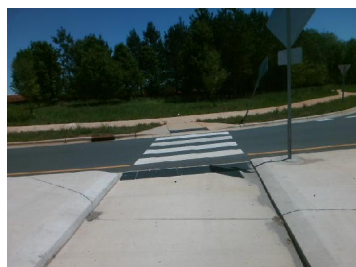
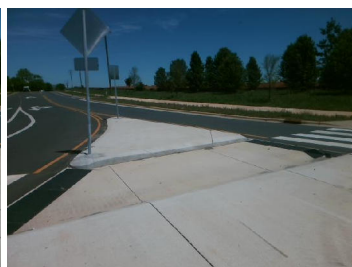
Compliance	Description	Data	Compliance	Description	Data
Yes	Refuge 1 Length (In)	124.5	N/A	Gutter 1 Ponding?	N/A
Yes	Refuge 1 Width (In)	110.0	N/A	Gutter 1 Lip Ht (In)	N/A
Yes	Refuge 1 Slope (%)	4.4	N/A	Gutter 1 Slope (%)	N/A
Yes	Refuge 1 X Slope (%)	3.9	N/A	Gutter 1 X Slope (%)	N/A
N/A	Painted X Walk1?	Yes	N/A	DWS 1 Provided?	N/A
N/A	X Walk 1 Direction	To NW	N/A	DWS 1 Contrast?	N/A
N/A	X Walk 1 Width (In)	122.0	N/A	DWS 1 Length (In)	N/A
N/A	Road 1 Slope (%)	4.4	N/A	DWS 1 Full Width?	N/A
N/A	Road 1 X Slope (%)	0.5	N/A	DWS 1 Offset (In)	N/A
Yes	Refuge 2 Length (In)	124.5	N/A	Gutter 2 Ponding?	N/A
Yes	Refuge 2 Width (In)	110.0	N/A	Gutter 2 Lip Ht (In)	N/A
Yes	Refuge 2 Slope (%)	0.7	N/A	Gutter 2 Slope (%)	N/A
Yes	Refuge 2 X Slope (%)	4.5	N/A	Gutter 2 X Slope (%)	N/A
N/A	Painted X Walk2?	Yes	N/A	DWS 2 Provided?	N/A
N/A	X Walk 2 Direction	To E	N/A	DWS 2 Contrast?	N/A
N/A	X Walk 2 Width (In)	121.0	N/A	DWS 2 Length (In)	N/A

N/A	Road 2 Slope (%)	3.4	N/A	DWS 2 Full Width?	N/A
N/A	Road 2 X Slope (%)	2.0	N/A	DWS 2 Offset (In)	N/A
N/A	Refuge 3 Length (in)	N/A	N/A	Gutter 3 Ponding?	N/A
N/A	Refuge 3 Width (in)	N/A	N/A	Gutter 3 Lip Ht (in)	N/A
N/A	Refuge 3 Slope (%)	N/A	N/A	Gutter 3 Slope (%)	N/A
N/A	Refuge 3 XSlope (%)	N/A	N/A	Gutter 3 XSlope (%)	N/A
N/A	Painted X Walk3?	N/A	N/A	DWS 3 Provided?	N/A
N/A	X Walk 3 Direction	N/A	N/A	DWS 3 Contrast?	N/A
N/A	X Walk 3 Width (in)	N/A	N/A	DWS 3 Length (in)	N/A
N/A	Road 3 Slope (%)	N/A	N/A	DWS 3 Full Width?	N/A
N/A	Road 3 XSlope (%)	N/A	N/A	DWS 3 Offset (in)	N/A
Yes	Any Obstructions?	N/A	N/A	Storm Grate/Utility Hazard?	N/A
N/A	Obstruction Type		N/A	Storm Grate/Utility Type	
		N/A			N/A
N/A	Surface Condition	Good

Remove & Replace Entire Refuge.
