Access Compliance Report

Public Rights-of-Way

(Island Curb Cuts)

Intersection ID: 44850	Main Street: STEELE_CREEK_RD	Cross Street: SHOPTON_RD_WEST	Location: S
ADA ID: 92A1D7908C07	Curb Cut Type: MedianRefuge2	Initial Pass/Fail: Fail	Overall Compliance: No
Codes/Mitigation Info/Possible Solution		Field Measurements/Component Compliance

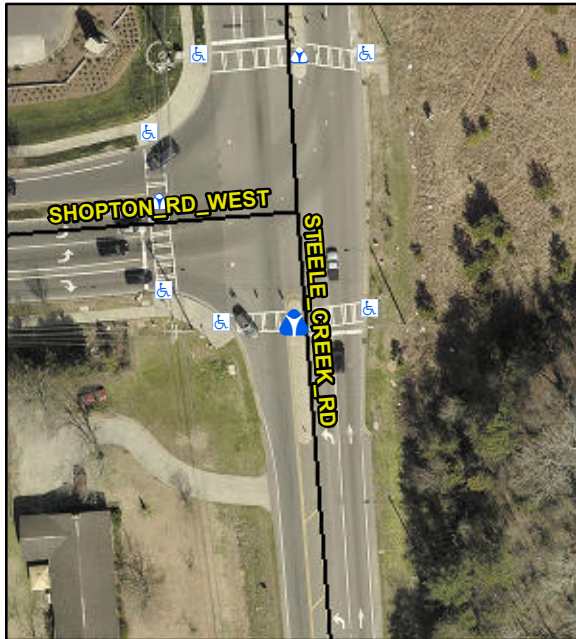
Compliance	Description	Data	Compliance	Description	Data
Yes	Refuge 1 Length (In)	48	N/A	Gutter 1 Ponding?	N/A
Yes	Refuge 1 Width (In)	98	N/A	Gutter 1 Lip Ht (In)	N/A
Yes	Refuge 1 Slope (%)	3.6	N/A	Gutter 1 Slope (%)	N/A
Yes	Refuge 1 X Slope (%)	2.4	N/A	Gutter 1 X Slope (%)	N/A
N/A	Painted X Walk1?	Yes	N/A	DWS 1 Provided?	N/A
N/A	X Walk 1 Direction	To W	N/A	DWS 1 Contrast?	N/A
N/A	X Walk 1 Width (In)	112	N/A	DWS 1 Length (In)	N/A
N/A	Road 1 Slope (%)	0.2	N/A	DWS 1 Full Width?	N/A
N/A	Road 1 X Slope (%)	4.1	N/A	DWS 1 Offset (In)	N/A
Yes	Refuge 2 Length (In)	48	N/A	Gutter 2 Ponding?	N/A
Yes	Refuge 2 Width (In)	98	N/A	Gutter 2 Lip Ht (In)	N/A
Yes	Refuge 2 Slope (%)	4.3	N/A	Gutter 2 Slope (%)	N/A
Yes	Refuge 2 X Slope (%)	0.7	N/A	Gutter 2 X Slope (%)	N/A
N/A	Painted X Walk2?	Yes	N/A	DWS 2 Provided?	N/A
N/A	X Walk 2 Direction	To E	N/A	DWS 2 Contrast?	N/A
N/A	X Walk 2 Width (In)	112	N/A	DWS 2 Length (In)	N/A
N/A	Road 2 Slope (%)	1.5	N/A	DWS 2 Full Width?	N/A

N/A	Road 2 X Slope (%)	4.4	N/A	DWS 2 Offset (In)	N/A
N/A	Refuge 3 Length (in)	N/A	N/A	Gutter 3 Ponding?	N/A
N/A	Refuge 3 Width (in)	N/A	N/A	Gutter 3 Lip Ht (in)	N/A
N/A	Refuge 3 Slope (%)	N/A	N/A	Gutter 3 Slope (%)	N/A
N/A	Refuge 3 XSlope (%)	N/A	N/A	Gutter 3 XSlope (%)	N/A
N/A	Painted X Walk3?	N/A	N/A	DWS 3 Provided?	N/A
N/A	X Walk 3 Direction	N/A	N/A	DWS 3 Contrast?	N/A
N/A	X Walk 3 Width (in)	N/A	N/A	DWS 3 Length (in)	N/A
N/A	Road 3 Slope (%)	N/A	N/A	DWS 3 Full Width?	N/A
N/A	Road 3 XSlope (%)	N/A	N/A	DWS 3 Offset (in)	N/A
Yes	Any Obstructions?	N/A	N/A	Storm Grate/Utility Hazard?	N/A
N/A	Obstruction Type		N/A	Storm Grate/Utility Type	
		N/A			N/A
N/A	Surface Condition	Good

Remove & Replace Entire Refuge.
