# Access Compliance Report

## Public Rights-of-Way

### (Island Curb Cuts)

Intersection ID: 8925	Main Street: E_W_T_HARRIS_BV	Cross Street: THE_PLAZA	Location: E
ADA ID: 92A721D872FA	Curb Cut Type: MedianRefuge2	Initial Pass/Fail: Pass	Overall Compliance: No
Codes/Mitigation Info/Possible Solution		Field Measurements/Component Compliance	
Severity Score: 10

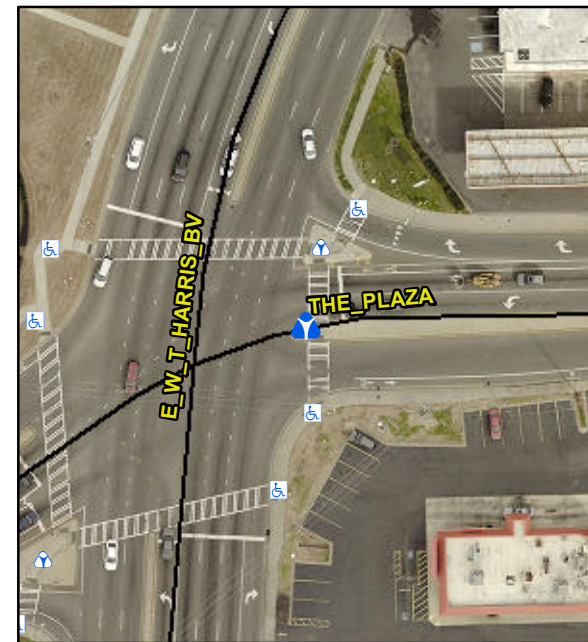
Compliance	Description	Data	Compliance	Description	Data
Yes	Refuge 1 Length (In)	42.5	No	Gutter 1 Ponding?	Yes
Yes	Refuge 1 Width (In)	72.0	Yes	Gutter 1 Lip Ht (In)	0.0
Yes	Refuge 1 Slope (%)	1.7	Yes	Gutter 1 Slope (%)	0.3
Yes	Refuge 1 X Slope (%)	0.8	Yes	Gutter 1 X Slope (%)	1.7
N/A	Painted X Walk1?	Yes	Yes	DWS 1 Provided?	Yes
N/A	X Walk 1 Direction	To S	Yes	DWS 1 Contrast?	Yes
N/A	X Walk 1 Width (In)	111.0	Yes	DWS 1 Length (In)	24.0
N/A	Road 1 Slope (%)	0.7	Yes	DWS 1 Full Width?	Yes
N/A	Road 1 X Slope (%)	2.2	Yes	DWS 1 Offset (In)	1.0
Yes	Refuge 2 Length (In)	42.5	No	Gutter 2 Ponding?	Yes
Yes	Refuge 2 Width (In)	72.0	Yes	Gutter 2 Lip Ht (In)	0.0
Yes	Refuge 2 Slope (%)	0.6	No	Gutter 2 Slope (%)	6.7
Yes	Refuge 2 X Slope (%)	1.3	Yes	Gutter 2 X Slope (%)	1.5
N/A	Painted X Walk2?	Yes	Yes	DWS 2 Provided?	Yes
N/A	X Walk 2 Direction	To N	Yes	DWS 2 Contrast?	Yes
N/A	X Walk 2 Width (In)	110.0	Yes	DWS 2 Length (In)	24.0

**Fix Gutter Ponding. Remove & Replace Gutter.**

Total Cost: \$ 1250.00
