# Access Compliance Report

## Public Rights-of-Way

### (Island Curb Cuts)

| Intersection ID: 52790 | Main Street: COLEMON_KERRY_DR | Cross Street: FRIENDSHIP_VILLAGE_PL | Location: | W |

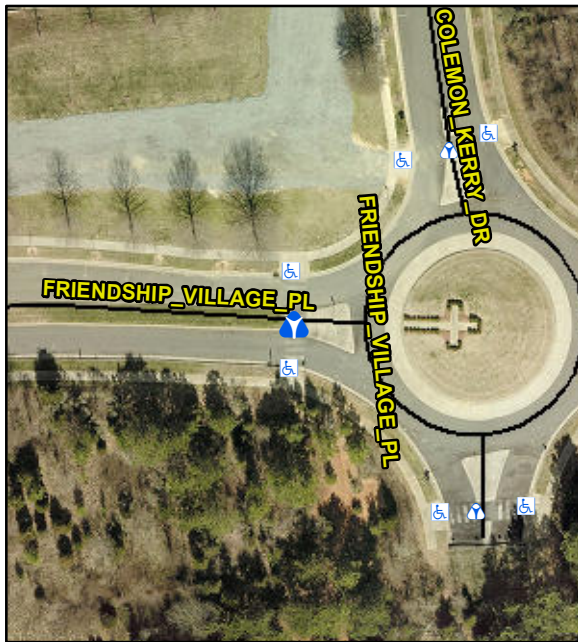
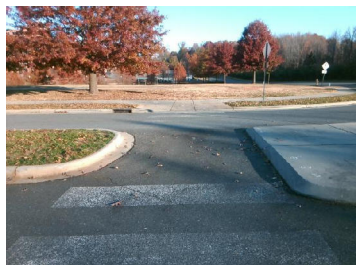
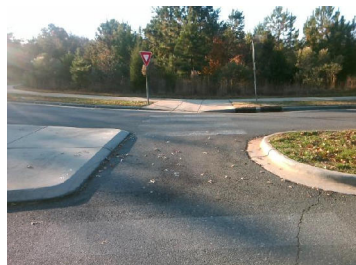
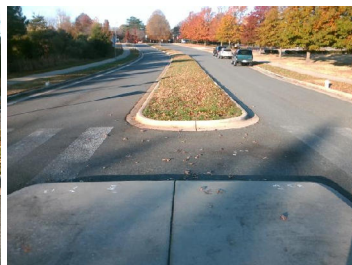
| ADA ID: 938A52F29A8D | Curb Cut Type: MedianRefuge2 | Initial Pass/Fail: Pass | Overall Compliance: No | Severity Score: 15 |

| Compliance | Description | Data | Compliance | Description | Data |
|---|---|---|---|---|---|
| N/A | Painted X Walk1? | No | No | DWS 1 Provided? | No |
| N/A | Painted X Walk2? | No | No | DWS 2 Provided? | No |

**Install Detectable Warning System.**
