# Access Compliance Report

## Public Rights-of-Way

### (Island Curb Cuts)

Intersection ID: 5966	Main Street: SUNSTONE_DR	Cross Street: STATESVILLE_RD	Location: S
ADA ID: 94EFF1A7D1EA	Curb Cut Type: MedianRefuge2	Initial Pass/Fail: Pass	Overall Compliance: No
Codes/Mitigation Info/Possible Solution		Field Measurements/Component Compliance	
Severity Score: 0.25

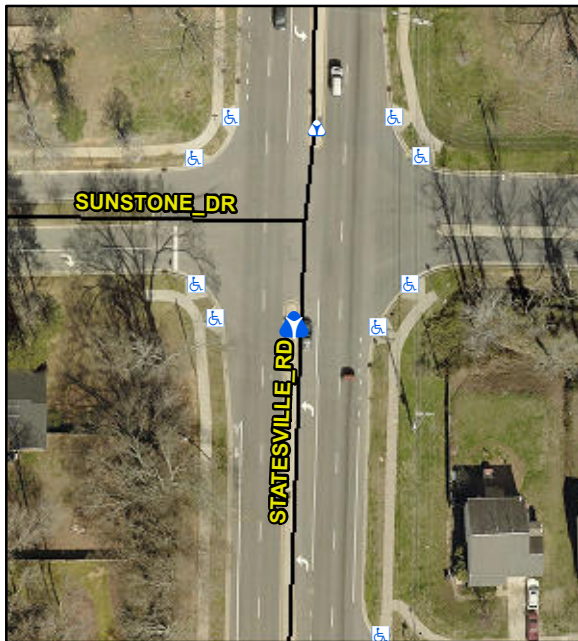
Compliance	Description	Data	Compliance	Description	Data
No	Refuge 1 Length (In)	35.5	No	Gutter 1 Ponding?	Yes
Yes	Refuge 1 Width (In)	96.0	Yes	Gutter 1 Lip Ht (In)	0.0
Yes	Refuge 1 Slope (%)	0.2	Yes	Gutter 1 Slope (%)	2.2
Yes	Refuge 1 X Slope (%)	0.8	Yes	Gutter 1 X Slope (%)	0.5
N/A	Painted X Walk1?	No	No	DWS 1 Provided?	Yes
N/A	X Walk 1 Direction	To E	N/A	DWS 1 Contrast?	Yes
N/A	X Walk 1 Width (In)	N/A	N/A	DWS 1 Length (In)	24.0
N/A	Road 1 Slope (%)	0.0	N/A	DWS 1 Full Width?	Yes
N/A	Road 1 X Slope (%)	2.0	N/A	DWS 1 Offset (In)	0.0
No	Refuge 2 Length (In)	35.5	No	Gutter 2 Ponding?	Yes
Yes	Refuge 2 Width (In)	96.0	Yes	Gutter 2 Lip Ht (In)	0.0
Yes	Refuge 2 Slope (%)	2.4	Yes	Gutter 2 Slope (%)	1.3
Yes	Refuge 2 X Slope (%)	0.8	Yes	Gutter 2 X Slope (%)	0.2
N/A	Painted X Walk2?	No	No	DWS 2 Provided?	Yes
N/A	X Walk 2 Direction	To W	N/A	DWS 2 Contrast?	Yes
N/A	X Walk 2 Width (In)	N/A	N/A	DWS 2 Length (In)	24.0
N/A	Road 2 Slope (%)	0.2	N/A	DWS 2 Full Width?	Yes

**Remove & Replace Entire Refuge.  
Fix Gutter Ponding.**
