# Access Compliance Report

## Public Rights-of-Way

### (Island Curb Cuts)

Intersection ID: 18818	Main Street: BEAM_RD	Cross Street: SHOPTON_RD	Location: E
ADA ID: 94F60A5ADAD3	Curb Cut Type: MedianRefuge2	Initial Pass/Fail: Fail	Overall Compliance: No
Codes/Mitigation Info/Possible Solution		Field Measurements/Component Compliance	
Severity Score: 0

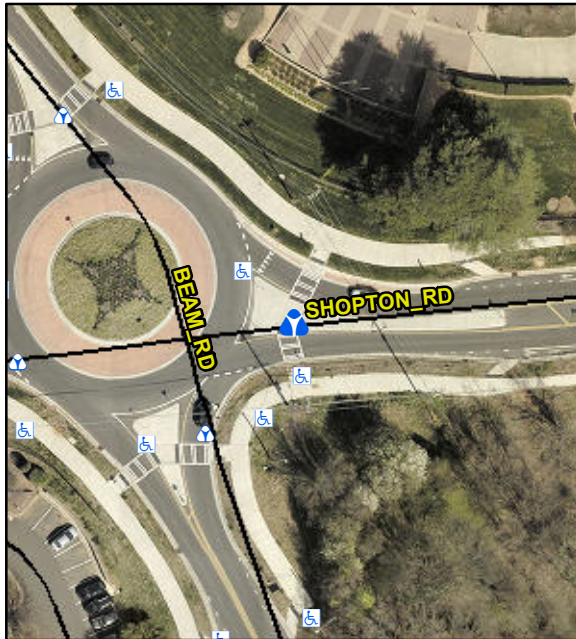
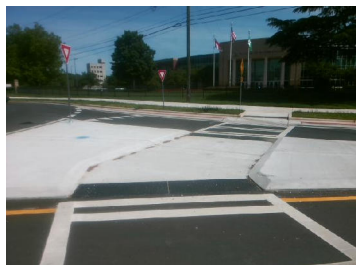
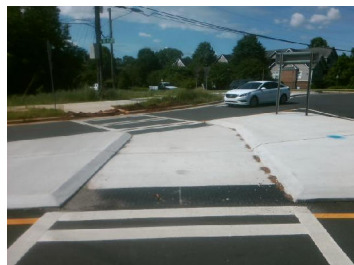
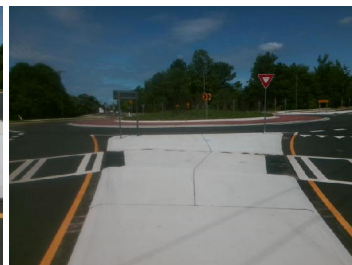
Compliance	Description	Data	Compliance	Description	Data
Yes	Refuge 1 Length (In)	105	N/A	Gutter 1 Ponding?	N/A
Yes	Refuge 1 Width (In)	120	N/A	Gutter 1 Lip Ht (In)	N/A
Yes	Refuge 1 Slope (%)	1.3	N/A	Gutter 1 Slope (%)	N/A
Yes	Refuge 1 X Slope (%)	2.3	N/A	Gutter 1 X Slope (%)	N/A
N/A	Painted X Walk1?	Yes	N/A	DWS 1 Provided?	N/A
N/A	X Walk 1 Direction	To S	N/A	DWS 1 Contrast?	N/A
N/A	X Walk 1 Width (In)	109	N/A	DWS 1 Length (In)	N/A
N/A	Road 1 Slope (%)	1.9	N/A	DWS 1 Full Width?	N/A
N/A	Road 1 X Slope (%)	3.8	N/A	DWS 1 Offset (In)	N/A
Yes	Refuge 2 Length (In)	105	N/A	Gutter 2 Ponding?	N/A
Yes	Refuge 2 Width (In)	120	N/A	Gutter 2 Lip Ht (In)	N/A
Yes	Refuge 2 Slope (%)	1.5	N/A	Gutter 2 Slope (%)	N/A
Yes	Refuge 2 X Slope (%)	1.7	N/A	Gutter 2 X Slope (%)	N/A
N/A	Painted X Walk2?	Yes	N/A	DWS 2 Provided?	N/A
N/A	X Walk 2 Direction	To N	N/A	DWS 2 Contrast?	N/A
N/A	X Walk 2 Width (In)	112	N/A	DWS 2 Length (In)	N/A

N/A	Road 2 Slope (%)	1.1	N/A	DWS 2 Full Width?	N/A
N/A	Road 2 X Slope (%)	2.6	N/A	DWS 2 Offset (In)	N/A
N/A	Refuge 3 Length (in)	N/A	N/A	Gutter 3 Ponding?	N/A
N/A	Refuge 3 Width (in)	N/A	N/A	Gutter 3 Lip Ht (in)	N/A
N/A	Refuge 3 Slope (%)	N/A	N/A	Gutter 3 Slope (%)	N/A
N/A	Refuge 3 XSlope (%)	N/A	N/A	Gutter 3 XSlope (%)	N/A
N/A	Painted X Walk3?	N/A	N/A	DWS 3 Provided?	N/A
N/A	X Walk 3 Direction	N/A	N/A	DWS 3 Contrast?	N/A
N/A	X Walk 3 Width (in)	N/A	N/A	DWS 3 Length (in)	N/A
N/A	Road 3 Slope (%)	N/A	N/A	DWS 3 Full Width?	N/A
N/A	Road 3 XSlope (%)	N/A	N/A	DWS 3 Offset (in)	N/A
Yes	Any Obstructions?	N/A	N/A	Storm Grate/Utility Hazard?	N/A
N/A	Obstruction Type		N/A	Storm Grate/Utility Type	
		N/A			N/A
N/A	Surface Condition	Good

**Remove & Replace Entire Refuge.**

**\$ 3000.00**
