Access Compliance Report

Public Rights-of-Way

(Island Curb Cuts)

Intersection ID: 12937	Main Street: E_W_T_HARRIS_BV	Cross Street: HICKORY_GROVE_RD	Location: S
ADA ID: 9555EDC82C46	Curb Cut Type: MedianRefuge2	Initial Pass/Fail: Pass	Overall Compliance: No
Severity Score: 0			
Codes/Mitigation Info/Possible Solution		Field Measurements/Component Compliance

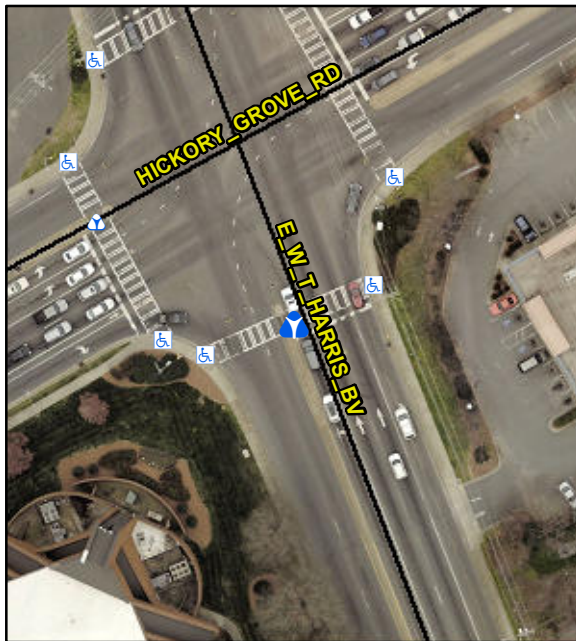
Compliance	Description	Data	Compliance	Description	Data
No	Refuge 1 Length (In)	30.0	Yes	Gutter 1 Ponding?	No
Yes	Refuge 1 Width (In)	95.0	Yes	Gutter 1 Lip Ht (In)	0.0
Yes	Refuge 1 Slope (%)	0.8	Yes	Gutter 1 Slope (%)	3.2
Yes	Refuge 1 X Slope (%)	0.1	Yes	Gutter 1 X Slope (%)	0.5
N/A	Painted X Walk1?	Yes	No	DWS 1 Provided?	Yes
N/A	X Walk 1 Direction	To NE	N/A	DWS 1 Contrast?	Yes
N/A	X Walk 1 Width (In)	111.5	N/A	DWS 1 Length (In)	24.0
N/A	Road 1 Slope (%)	0.8	N/A	DWS 1 Full Width?	Yes
N/A	Road 1 X Slope (%)	0.2	N/A	DWS 1 Offset (In)	0.0
No	Refuge 2 Length (In)	30.0	Yes	Gutter 2 Ponding?	No
Yes	Refuge 2 Width (In)	95.0	Yes	Gutter 2 Lip Ht (In)	0.0
Yes	Refuge 2 Slope (%)	0.5	Yes	Gutter 2 Slope (%)	3.3
Yes	Refuge 2 X Slope (%)	0.2	Yes	Gutter 2 X Slope (%)	0.4
N/A	Painted X Walk2?	Yes	No	DWS 2 Provided?	Yes
N/A	X Walk 2 Direction	To SW	N/A	DWS 2 Contrast?	Yes
N/A	X Walk 2 Width (In)	111.0	N/A	DWS 2 Length (In)	24.0

Remove & Replace Entire Refuge.

Total Cost: \$ 3000.00
