Access Compliance Report

Public Rights-of-Way

(Island Curb Cuts)

Intersection ID: 8857	Main Street: DORTON_ST	Cross Street: N_TRYON_ST	Location: W
ADA ID: 95618BA2F866	Curb Cut Type: MedianRefuge2	Initial Pass/Fail: Fail	Overall Compliance: No
Codes/Mitigation Info/Possible Solution		Field Measurements/Component Compliance	
Severity Score: 15

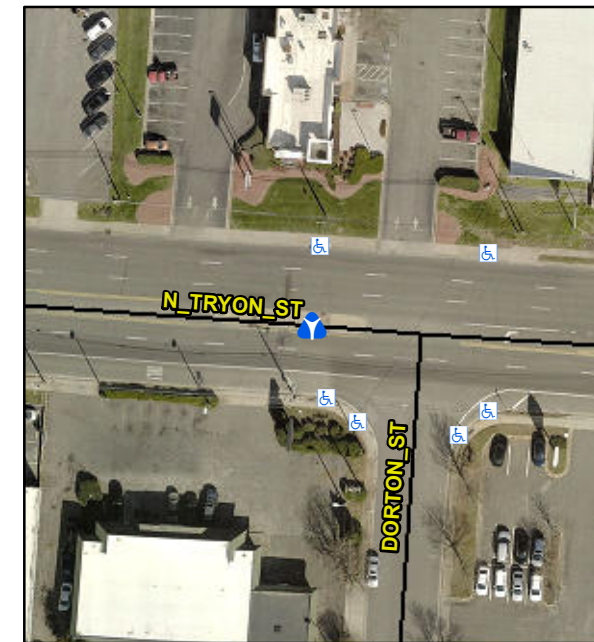
Compliance	Description	Data	Compliance	Description	Data
Yes	Refuge 1 Length (In)	59.0	N/A	Gutter 1 Ponding?	N/A
Yes	Refuge 1 Width (In)	70.0	N/A	Gutter 1 Lip Ht (In)	N/A
Yes	Refuge 1 Slope (%)	1.6	N/A	Gutter 1 Slope (%)	N/A
Yes	Refuge 1 X Slope (%)	2.0	N/A	Gutter 1 X Slope (%)	N/A
N/A	Painted X Walk1?	No	N/A	DWS 1 Provided?	N/A
N/A	X Walk 1 Direction	To SW	N/A	DWS 1 Contrast?	N/A
N/A	X Walk 1 Width (In)	N/A	N/A	DWS 1 Length (In)	N/A
N/A	Road 1 Slope (%)	2.6	N/A	DWS 1 Full Width?	N/A
N/A	Road 1 X Slope (%)	1.2	N/A	DWS 1 Offset (In)	N/A
Yes	Refuge 2 Length (In)	59.0	N/A	Gutter 2 Ponding?	N/A
Yes	Refuge 2 Width (In)	70.0	N/A	Gutter 2 Lip Ht (In)	N/A
Yes	Refuge 2 Slope (%)	1.7	N/A	Gutter 2 Slope (%)	N/A
Yes	Refuge 2 X Slope (%)	1.0	N/A	Gutter 2 X Slope (%)	N/A
N/A	Painted X Walk2?	No	N/A	DWS 2 Provided?	N/A
N/A	X Walk 2 Direction	To NW	N/A	DWS 2 Contrast?	N/A
N/A	X Walk 2 Width (In)	N/A	N/A	DWS 2 Length (In)	N/A

N/A	Road 2 Slope (%)	2.8	N/A	DWS 2 Full Width?	N/A
N/A	Road 2 X Slope (%)	4.0	N/A	DWS 2 Offset (In)	N/A
N/A	Refuge 3 Length (in)	N/A	N/A	Gutter 3 Ponding?	N/A
N/A	Refuge 3 Width (in)	N/A	N/A	Gutter 3 Lip Ht (in)	N/A
N/A	Refuge 3 Slope (%)	N/A	N/A	Gutter 3 Slope (%)	N/A
N/A	Refuge 3 XSlope (%)	N/A	N/A	Gutter 3 XSlope (%)	N/A
N/A	Painted X Walk3?	No	N/A	DWS 3 Provided?	N/A
N/A	X Walk 3 Direction	N/A	N/A	DWS 3 Contrast?	N/A
N/A	X Walk 3 Width (in)	N/A	N/A	DWS 3 Length (in)	N/A
N/A	Road 3 Slope (%)	N/A	N/A	DWS 3 Full Width?	N/A
N/A	Road 3 XSlope (%)	N/A	N/A	DWS 3 Offset (in)	N/A
Yes	Any Obstructions?	N/A	N/A	Storm Grate/Utility Hazard?	N/A
N/A	Obstruction Type		N/A	Storm Grate/Utility Type	
		N/A			N/A
No	Surface Condition	Poor

Remove & Replace Entire Refuge.
