Access Compliance Report

Public Rights-of-Way

(Island Curb Cuts)

Intersection ID: 27388	Main Street: CONLAN_CR	Cross Street: BRIXHAM_HILL_AV	Location: E
ADA ID: 95C63B0FE5AD	Curb Cut Type: MedianRefuge2	Initial Pass/Fail: Fail	Overall Compliance: No
Severity Score: 1.25			
Codes/Mitigation Info/Possible Solution		Field Measurements/Component Compliance

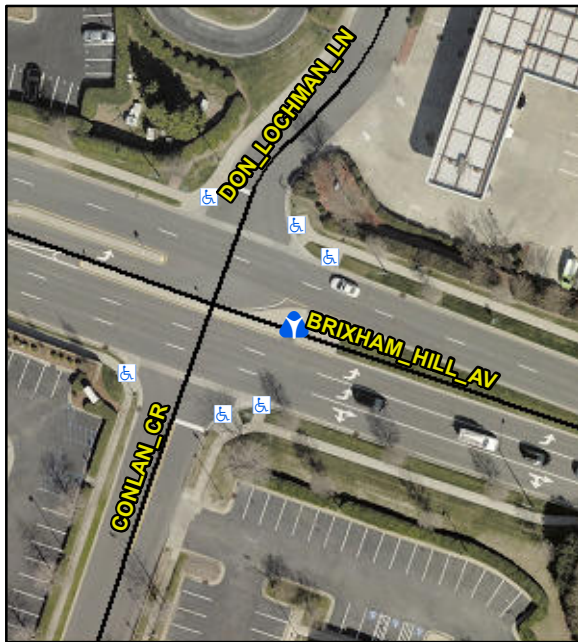
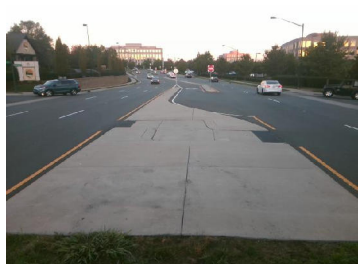
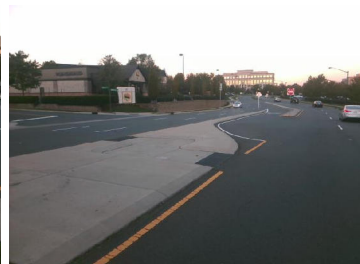
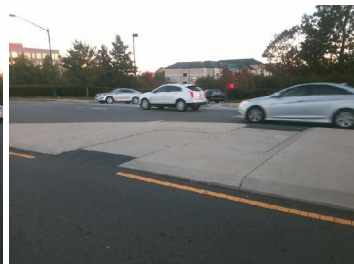
Compliance	Description	Data	Compliance	Description	Data
Yes	Refuge 1 Length (In)	149.0	N/A	Gutter 1 Ponding?	N/A
Yes	Refuge 1 Width (In)	70.0	N/A	Gutter 1 Lip Ht (In)	N/A
Yes	Refuge 1 Slope (%)	2.3	N/A	Gutter 1 Slope (%)	N/A
Yes	Refuge 1 X Slope (%)	3.2	N/A	Gutter 1 X Slope (%)	N/A
N/A	Painted X Walk1?	No	N/A	DWS 1 Provided?	N/A
N/A	X Walk 1 Direction	To N	N/A	DWS 1 Contrast?	N/A
N/A	X Walk 1 Width (In)	N/A	N/A	DWS 1 Length (In)	N/A
N/A	Road 1 Slope (%)	2.5	N/A	DWS 1 Full Width?	N/A
N/A	Road 1 X Slope (%)	4.7	N/A	DWS 1 Offset (In)	N/A
Yes	Refuge 2 Length (In)	139.0	N/A	Gutter 2 Ponding?	N/A
Yes	Refuge 2 Width (In)	70.0	N/A	Gutter 2 Lip Ht (In)	N/A
Yes	Refuge 2 Slope (%)	2.2	N/A	Gutter 2 Slope (%)	N/A
Yes	Refuge 2 X Slope (%)	3.0	N/A	Gutter 2 X Slope (%)	N/A
N/A	Painted X Walk2?	No	N/A	DWS 2 Provided?	N/A
N/A	X Walk 2 Direction	To S	N/A	DWS 2 Contrast?	N/A
N/A	X Walk 2 Width (In)	N/A	N/A	DWS 2 Length (In)	N/A

N/A	Road 2 Slope (%)	2.8	N/A	DWS 2 Full Width?	N/A
N/A	Road 2 X Slope (%)	6.2	N/A	DWS 2 Offset (In)	N/A
N/A	Refuge 3 Length (in)	N/A	N/A	Gutter 3 Ponding?	N/A
N/A	Refuge 3 Width (in)	N/A	N/A	Gutter 3 Lip Ht (in)	N/A
N/A	Refuge 3 Slope (%)	N/A	N/A	Gutter 3 Slope (%)	N/A
N/A	Refuge 3 XSlope (%)	N/A	N/A	Gutter 3 XSlope (%)	N/A
N/A	Painted X Walk3?	N/A	N/A	DWS 3 Provided?	N/A
N/A	X Walk 3 Direction	N/A	N/A	DWS 3 Contrast?	N/A
N/A	X Walk 3 Width (in)	N/A	N/A	DWS 3 Length (in)	N/A
N/A	Road 3 Slope (%)	N/A	N/A	DWS 3 Full Width?	N/A
N/A	Road 3 XSlope (%)	N/A	N/A	DWS 3 Offset (in)	N/A
Yes	Any Obstructions?	N/A	N/A	Storm Grate/Utility Hazard?	N/A
N/A	Obstruction Type		N/A	Storm Grate/Utility Type	
		N/A			N/A
N/A	Surface Condition	Good

Remove & Replace Entire Refuge.
