# Access Compliance Report

## Public Rights-of-Way

### (Island Curb Cuts)

Intersection ID: 6640	Main Street: ARVIN_DR	Cross Street: COCHRANE_DR	Location: S
ADA ID: 96A075A15224	Curb Cut Type: MedianRefuge2	Initial Pass/Fail: Pass	Overall Compliance: No
Severity Score: 7.75			
Codes/Mitigation Info/Possible Solution		Field Measurements/Component Compliance

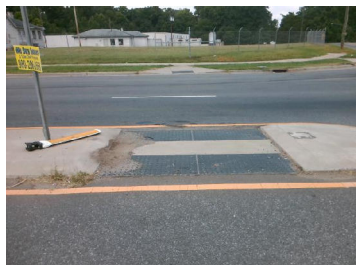
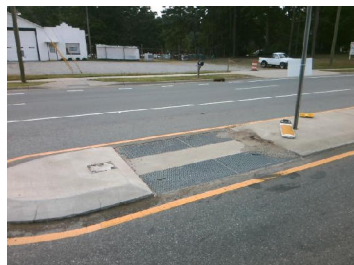
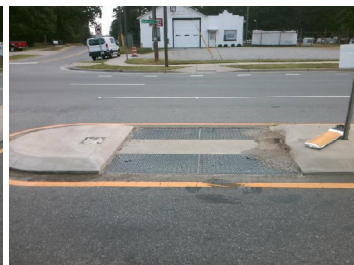
Compliance	Description	Data	Compliance	Description	Data
Yes	Refuge 1 Length (In)	36.0	No	Gutter 1 Ponding?	Yes
Yes	Refuge 1 Width (In)	96.5	No	Gutter 1 Lip Ht (In)	0.5
Yes	Refuge 1 Slope (%)	1.3	Yes	Gutter 1 Slope (%)	2.6
Yes	Refuge 1 X Slope (%)	0.4	Yes	Gutter 1 X Slope (%)	0.7
N/A	Painted X Walk1?	No	Yes	DWS 1 Provided?	Yes
N/A	X Walk 1 Direction	To E	Yes	DWS 1 Contrast?	Yes
N/A	X Walk 1 Width (In)	N/A	Yes	DWS 1 Length (In)	24.0
N/A	Road 1 Slope (%)	0.7	Yes	DWS 1 Full Width?	Yes
N/A	Road 1 X Slope (%)	4.3	Yes	DWS 1 Offset (In)	0.0
Yes	Refuge 2 Length (In)	36.0	No	Gutter 2 Ponding?	Yes
Yes	Refuge 2 Width (In)	96.5	Yes	Gutter 2 Lip Ht (In)	0.0
Yes	Refuge 2 Slope (%)	2.8	Yes	Gutter 2 Slope (%)	2.4
Yes	Refuge 2 X Slope (%)	0.7	Yes	Gutter 2 X Slope (%)	0.9
N/A	Painted X Walk2?	No	Yes	DWS 2 Provided?	Yes
N/A	X Walk 2 Direction	To W	Yes	DWS 2 Contrast?	Yes
N/A	X Walk 2 Width (In)	N/A	Yes	DWS 2 Length (In)	24.0

N/A	Road 2 Slope (%)	0.8	Yes	DWS 2 Full Width?	Yes
N/A	Road 2 X Slope (%)	3.0	Yes	DWS 2 Offset (In)	0.0
N/A	Refuge 3 Length (in)	N/A	N/A	Gutter 3 Ponding?	No
N/A	Refuge 3 Width (in)	N/A	N/A	Gutter 3 Lip Ht (in)	N/A
N/A	Refuge 3 Slope (%)	N/A	N/A	Gutter 3 Slope (%)	N/A
N/A	Refuge 3 XSlope (%)	N/A	N/A	Gutter 3 XSlope (%)	N/A
N/A	Painted X Walk3?	No	N/A	DWS 3 Provided?	N/A
N/A	X Walk 3 Direction	N/A	N/A	DWS 3 Contrast?	N/A
N/A	X Walk 3 Width (in)	N/A	N/A	DWS 3 Length (in)	N/A
N/A	Road 3 Slope (%)	N/A	N/A	DWS 3 Full Width?	N/A
N/A	Road 3 XSlope (%)	N/A	N/A	DWS 3 Offset (in)	N/A
Yes	Any Obstructions?	No	N/A	Storm Grate/Utility Hazard?	No
N/A	Obstruction Type		N/A	Storm Grate/Utility Type	
N/A	Surface Condition	Good	N/A		N/A

**Fix Gutter Ponding. Grind Gutter Lip.**
