Access Compliance Report

Public Rights-of-Way

(Island Curb Cuts)

Intersection ID: 52289	Main Street: TROJAN_DR	Cross Street: DIXIE_RIVER_RD	Location: NW
ADA ID: 97C5E6A22386	Curb Cut Type: MedianRefuge2	Initial Pass/Fail: Fail	Overall Compliance: No
Severity Score: 13.75			
Codes/Mitigation Info/Possible Solution		Field Measurements/Component Compliance

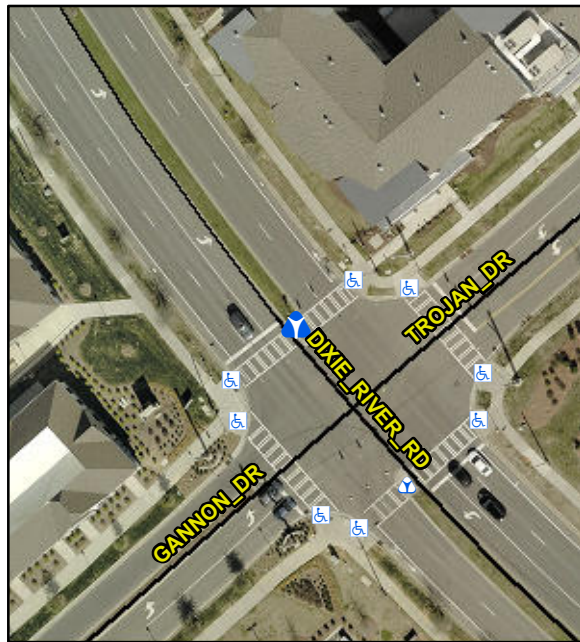
Compliance	Description	Data	Compliance	Description	Data
No	Refuge 1 Length (In)	33.0	N/A	Gutter 1 Ponding?	N/A
Yes	Refuge 1 Width (In)	112.0	N/A	Gutter 1 Lip Ht (In)	N/A
Yes	Refuge 1 Slope (%)	2.8	N/A	Gutter 1 Slope (%)	N/A
No	Refuge 1 X Slope (%)	6.3	N/A	Gutter 1 X Slope (%)	N/A
N/A	Painted X Walk1?	Yes	N/A	DWS 1 Provided?	N/A
N/A	X Walk 1 Direction	To NE	N/A	DWS 1 Contrast?	N/A
N/A	X Walk 1 Width (In)	111.0	N/A	DWS 1 Length (In)	N/A
N/A	Road 1 Slope (%)	1.6	N/A	DWS 1 Full Width?	N/A
N/A	Road 1 X Slope (%)	4.3	N/A	DWS 1 Offset (In)	N/A
No	Refuge 2 Length (In)	33.0	N/A	Gutter 2 Ponding?	N/A
Yes	Refuge 2 Width (In)	112.0	N/A	Gutter 2 Lip Ht (In)	N/A
Yes	Refuge 2 Slope (%)	2.9	N/A	Gutter 2 Slope (%)	N/A
Yes	Refuge 2 X Slope (%)	4.9	N/A	Gutter 2 X Slope (%)	N/A
N/A	Painted X Walk2?	Yes	N/A	DWS 2 Provided?	N/A
N/A	X Walk 2 Direction	To SW	N/A	DWS 2 Contrast?	N/A
N/A	X Walk 2 Width (In)	112.0	N/A	DWS 2 Length (In)	N/A

Remove & Replace Entire Refuge.

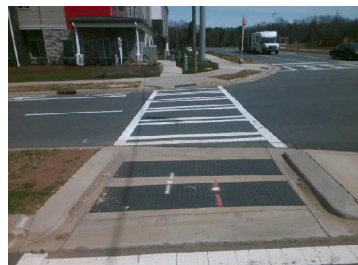
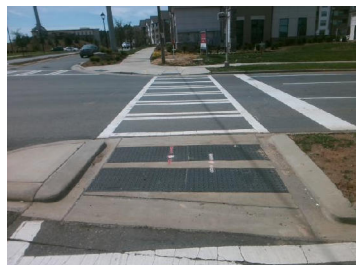
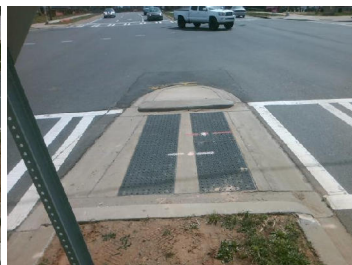
N/A	Road 2 Slope (%)	2.1	N/A	DWS 2 Full Width?	N/A
N/A	Road 2 X Slope (%)	2.9	N/A	DWS 2 Offset (In)	N/A
N/A	Refuge 3 Length (in)	N/A	N/A	Gutter 3 Ponding?	N/A
N/A	Refuge 3 Width (in)	N/A	N/A	Gutter 3 Lip Ht (in)	N/A
N/A	Refuge 3 Slope (%)	N/A	N/A	Gutter 3 Slope (%)	N/A
N/A	Refuge 3 XSlope (%)	N/A	N/A	Gutter 3 XSlope (%)	N/A
N/A	Painted X Walk3?	N/A	N/A	DWS 3 Provided?	N/A
N/A	X Walk 3 Direction	N/A	N/A	DWS 3 Contrast?	N/A
N/A	X Walk 3 Width (in)	N/A	N/A	DWS 3 Length (in)	N/A
N/A	Road 3 Slope (%)	N/A	N/A	DWS 3 Full Width?	N/A
N/A	Road 3 XSlope (%)	N/A	N/A	DWS 3 Offset (in)	N/A
Yes	Any Obstructions?	N/A	N/A	Storm Grate/Utility Hazard?	N/A
N/A	Obstruction Type		N/A	Storm Grate/Utility Type	
		N/A			N/A
N/A	Surface Condition	Good
