Access Compliance Report

Public Rights-of-Way

(Island Curb Cuts)

Intersection ID: 24549	Main Street: I-485_RA	Cross Street: SOUTH_BV	Location: SE
ADA ID: 97D105EBD00F	Curb Cut Type: MedianRefuge2	Initial Pass/Fail: Fail	Overall Compliance: No
Codes/Mitigation Info/Possible Solution		Field Measurements/Component Compliance	
Severity Score: 0

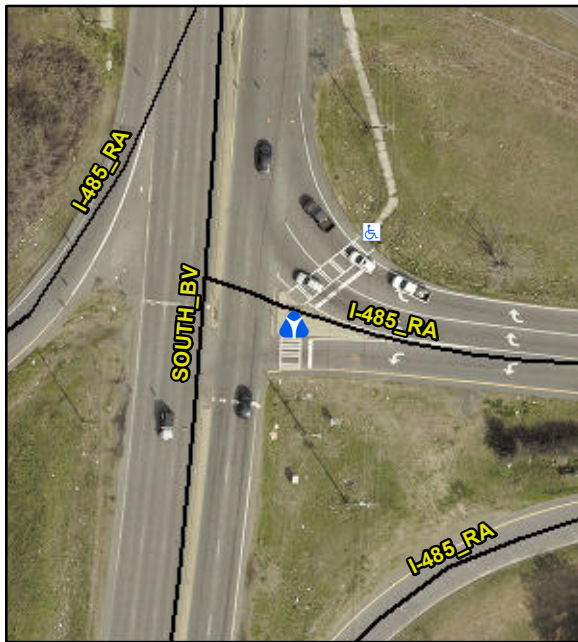
Compliance	Description	Data	Compliance	Description	Data
Yes	Refuge 1 Length (In)	90.0	N/A	Gutter 1 Ponding?	N/A
Yes	Refuge 1 Width (In)	101.0	N/A	Gutter 1 Lip Ht (In)	N/A
Yes	Refuge 1 Slope (%)	1.5	N/A	Gutter 1 Slope (%)	N/A
Yes	Refuge 1 X Slope (%)	4.1	N/A	Gutter 1 X Slope (%)	N/A
N/A	Painted X Walk1?	Yes	N/A	DWS 1 Provided?	N/A
N/A	X Walk 1 Direction	To NE	N/A	DWS 1 Contrast?	N/A
N/A	X Walk 1 Width (In)	122.0	N/A	DWS 1 Length (In)	N/A
N/A	Road 1 Slope (%)	2.2	N/A	DWS 1 Full Width?	N/A
N/A	Road 1 X Slope (%)	0.7	N/A	DWS 1 Offset (In)	N/A
Yes	Refuge 2 Length (In)	90.0	N/A	Gutter 2 Ponding?	N/A
Yes	Refuge 2 Width (In)	101.0	N/A	Gutter 2 Lip Ht (In)	N/A
Yes	Refuge 2 Slope (%)	0.2	N/A	Gutter 2 Slope (%)	N/A
Yes	Refuge 2 X Slope (%)	2.7	N/A	Gutter 2 X Slope (%)	N/A
N/A	Painted X Walk2?	Yes	N/A	DWS 2 Provided?	N/A
N/A	X Walk 2 Direction	To S	N/A	DWS 2 Contrast?	N/A
N/A	X Walk 2 Width (In)	113.0	N/A	DWS 2 Length (In)	N/A

N/A	Road 2 Slope (%)	2.4	N/A	DWS 2 Full Width?	N/A
N/A	Road 2 X Slope (%)	4.8	N/A	DWS 2 Offset (In)	N/A
N/A	Refuge 3 Length (in)	N/A	N/A	Gutter 3 Ponding?	N/A
N/A	Refuge 3 Width (in)	N/A	N/A	Gutter 3 Lip Ht (in)	N/A
N/A	Refuge 3 Slope (%)	N/A	N/A	Gutter 3 Slope (%)	N/A
N/A	Refuge 3 XSlope (%)	N/A	N/A	Gutter 3 XSlope (%)	N/A
N/A	Painted X Walk3?	N/A	N/A	DWS 3 Provided?	N/A
N/A	X Walk 3 Direction	N/A	N/A	DWS 3 Contrast?	N/A
N/A	X Walk 3 Width (in)	N/A	N/A	DWS 3 Length (in)	N/A
N/A	Road 3 Slope (%)	N/A	N/A	DWS 3 Full Width?	N/A
N/A	Road 3 XSlope (%)	N/A	N/A	DWS 3 Offset (in)	N/A
Yes	Any Obstructions?	N/A	N/A	Storm Grate/Utility Hazard?	N/A
N/A	Obstruction Type		N/A	Storm Grate/Utility Type	
		N/A			N/A
N/A	Surface Condition	Good

Possible Solutions:

Remove & Replace Entire Refuge.
