Access Compliance Report

Public Rights-of-Way

(Island Curb Cuts)

| Intersection ID: 28003 | Main Street: COMMUNITY_HOUSE_RD | Cross Street: WILLOW_ROCK_DR | Location: W |

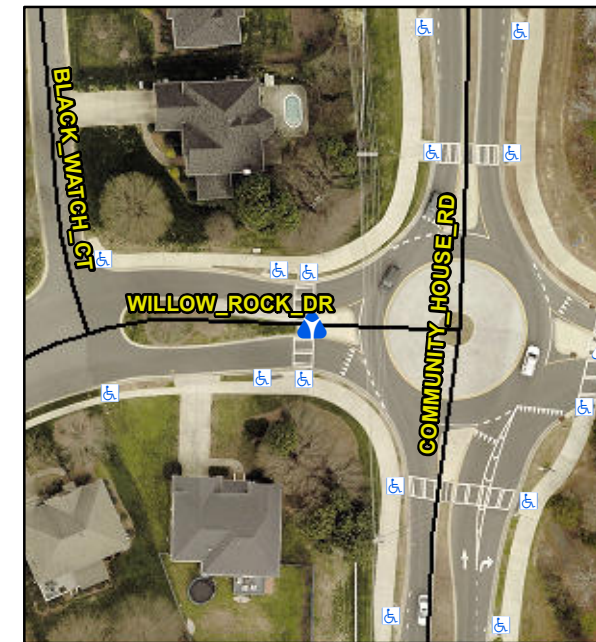
| ADA ID: 9826BE290C46 | Curb Cut Type: MedianRefuge2 | Initial Pass/Fail: Fail | Overall Compliance: No |
| Severity Score: 1.25 | | | |

Remove & Replace Entire Refuge.
