# Access Compliance Report

## Public Rights-of-Way

### (Island Curb Cuts)

| Intersection ID: 15800 | Main Street: PROVIDENCE_RD | Cross Street: QUEENS_RD | Location: NW |

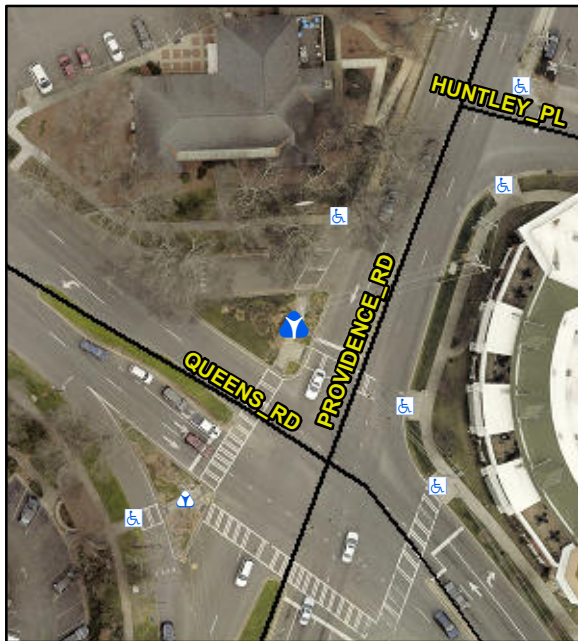
| ADA ID: 98696827E2C7 | Curb Cut Type: IslandRefuge3 | Initial Pass/Fail: Fail | Overall Compliance: No |
| Severity Score: 60 | | | |

| Compliance | Description | Data | Compliance | Description | Data |
|---|---|---|---|---|---|
| No | Refuge 3 Slope (%) | 7.5 | N/A | Gutter 3 Slope (%) | N/A |

**Remove & Replace Entire Refuge.**

Total Cost: \$ 3000.00
