# Access Compliance Report

## Public Rights-of-Way

### (Island Curb Cuts)

Intersection ID: 8739	Main Street: N_TRYON_ST	Cross Street: W_EASTWAY_DR	Location: SE
ADA ID: 9A35AFB9BFB3	Curb Cut Type: IslandRefuge3	Initial Pass/Fail: Pass	Overall Compliance: No
Severity Score: 12.75

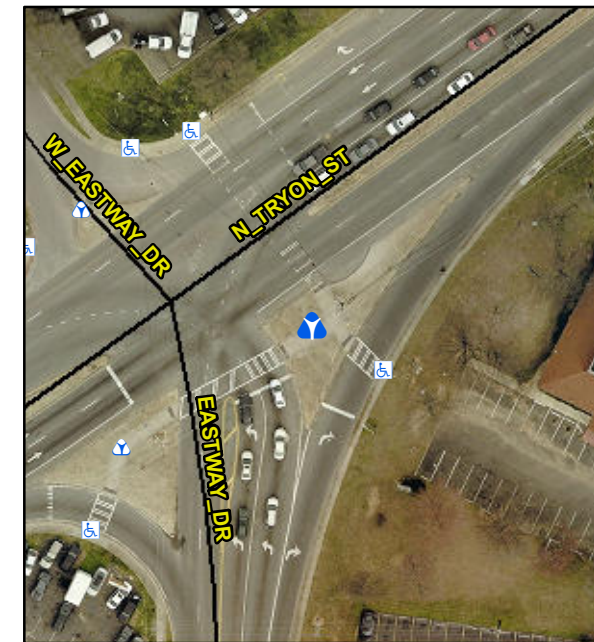
N/A	Road 2 Slope (%)	0.8	Yes	DWS 2 Full Width?	Yes
N/A	Road 2 X Slope (%)	1.6	Yes	DWS 2 Offset (In)	0.0
Yes	Refuge 3 Length (in)	197.0	Yes	Gutter 3 Ponding?	No
Yes	Refuge 3 Width (in)	97.0	No	Gutter 3 Lip Ht (in)	0.5
Yes	Refuge 3 Slope (%)	2.2	Yes	Gutter 3 Slope (%)	2.3
Yes	Refuge 3 XSlope (%)	0.6	Yes	Gutter 3 XSlope (%)	1.0
N/A	Painted X Walk3?	Yes	Yes	DWS 3 Provided?	Yes
N/A	X Walk 3 Direction	To NW	Yes	DWS 3 Contrast?	Yes
N/A	X Walk 3 Width (in)	109.5	Yes	DWS 3 Length (in)	24.0
N/A	Road 3 Slope (%)	0.7	Yes	DWS 3 Full Width?	Yes
N/A	Road 3 XSlope (%)	0.5	Yes	DWS 3 Offset (in)	0.0
Yes	Any Obstructions?	No	N/A	Storm Grate/Utility Hazard?	No
N/A	Obstruction Type	N/A	N/A	Storm Grate/Utility Type	N/A
N/A	Surface Condition	Good

**Grind Gutter Lip.**

**\$ 400.00**
