Access Compliance Report

Public Rights-of-Way

(Island Curb Cuts)

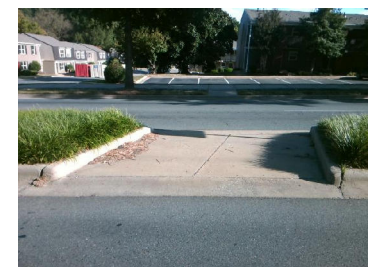
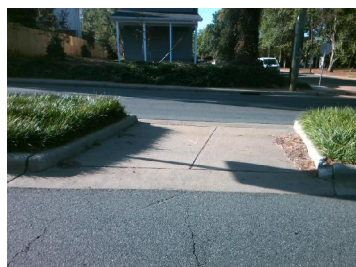
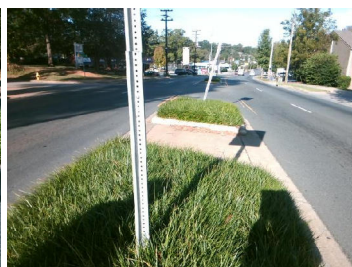
Intersection ID: 13588	Main Street: CENTRAL_AV	Cross Street: WEMBLEY_DR	Location: E
ADA ID: 9AA281C9D6AB	Curb Cut Type: MedianRefuge2	Initial Pass/Fail: Fail	Overall Compliance: No
Severity Score: 1.25			
Codes/Mitigation Info/Possible Solution		Field Measurements/Component Compliance

Compliance	Description	Data	Compliance	Description	Data
Yes	Refuge 1 Length (In)	51.0	N/A	Gutter 1 Ponding?	N/A
Yes	Refuge 1 Width (In)	118.0	N/A	Gutter 1 Lip Ht (In)	N/A
Yes	Refuge 1 Slope (%)	1.2	N/A	Gutter 1 Slope (%)	N/A
Yes	Refuge 1 X Slope (%)	3.9	N/A	Gutter 1 X Slope (%)	N/A
N/A	Painted X Walk1?	No	N/A	DWS 1 Provided?	N/A
N/A	X Walk 1 Direction	To S	N/A	DWS 1 Contrast?	N/A
N/A	X Walk 1 Width (In)	N/A	N/A	DWS 1 Length (In)	N/A
N/A	Road 1 Slope (%)	4.6	N/A	DWS 1 Full Width?	N/A
N/A	Road 1 X Slope (%)	2.0	N/A	DWS 1 Offset (In)	N/A
Yes	Refuge 2 Length (In)	51.0	N/A	Gutter 2 Ponding?	N/A
Yes	Refuge 2 Width (In)	118.0	N/A	Gutter 2 Lip Ht (In)	N/A
Yes	Refuge 2 Slope (%)	2.3	N/A	Gutter 2 Slope (%)	N/A
Yes	Refuge 2 X Slope (%)	4.6	N/A	Gutter 2 X Slope (%)	N/A
N/A	Painted X Walk2?	No	N/A	DWS 2 Provided?	N/A
N/A	X Walk 2 Direction	To N	N/A	DWS 2 Contrast?	N/A
N/A	X Walk 2 Width (In)	N/A	N/A	DWS 2 Length (In)	N/A

N/A	Road 2 Slope (%)	4.2	N/A	DWS 2 Full Width?	N/A
N/A	Road 2 X Slope (%)	7.2	N/A	DWS 2 Offset (In)	N/A
N/A	Refuge 3 Length (in)	N/A	N/A	Gutter 3 Ponding?	N/A
N/A	Refuge 3 Width (in)	N/A	N/A	Gutter 3 Lip Ht (in)	N/A
N/A	Refuge 3 Slope (%)	N/A	N/A	Gutter 3 Slope (%)	N/A
N/A	Refuge 3 XSlope (%)	N/A	N/A	Gutter 3 XSlope (%)	N/A
N/A	Painted X Walk3?	N/A	N/A	DWS 3 Provided?	N/A
N/A	X Walk 3 Direction	N/A	N/A	DWS 3 Contrast?	N/A
N/A	X Walk 3 Width (in)	N/A	N/A	DWS 3 Length (in)	N/A
N/A	Road 3 Slope (%)	N/A	N/A	DWS 3 Full Width?	N/A
N/A	Road 3 XSlope (%)	N/A	N/A	DWS 3 Offset (in)	N/A
Yes	Any Obstructions?	N/A	N/A	Storm Grate/Utility Hazard?	N/A
N/A	Obstruction Type		N/A	Storm Grate/Utility Type	
		N/A			N/A
N/A	Surface Condition	Good

Remove & Replace Entire Refuge.
