Access Compliance Report

Public Rights-of-Way

(Island Curb Cuts)

| Intersection ID: 45096 | Main Street: E_9TH_ST | Cross Street: N_DAVIDSON_ST | Location: NE |

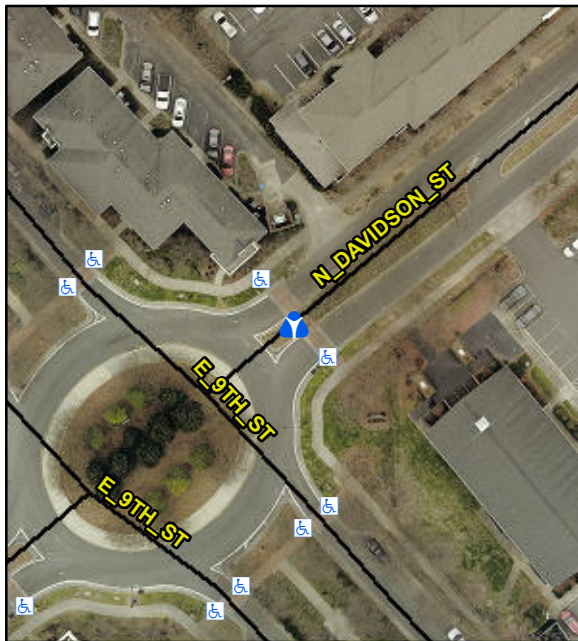
| ADA ID: 9AC703F5763C | Curb Cut Type: MedianRefuge2 | Initial Pass/Fail: Fail | Overall Compliance: No |
| Severity Score: 1.25 | | | |

Possible Solutions:

Remove & Replace Entire Refuge.
