Access Compliance Report

Public Rights-of-Way

(Island Curb Cuts)

Intersection ID: 53488	Main Street: WAVERLY_WALK_AV	Cross Street: N/A	Location: S
ADA ID: 9CDE571F869D	Curb Cut Type: MedianRefuge2	Initial Pass/Fail: Fail	Overall Compliance: No
		Severity Score: 0

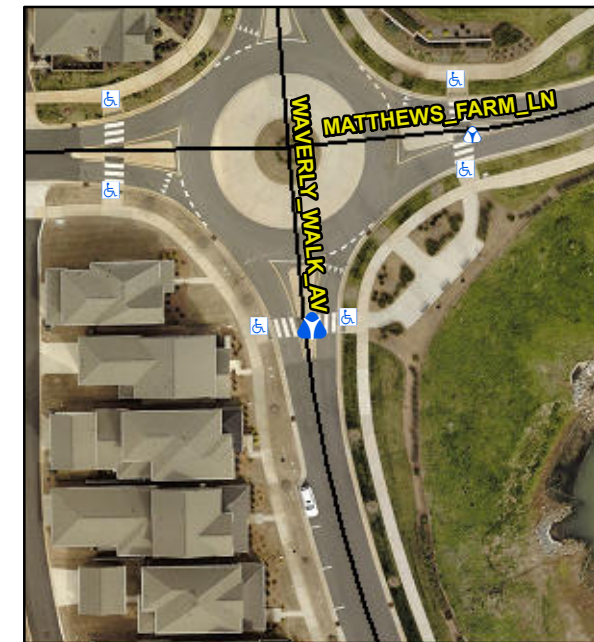
Compliance	Description	Data	Compliance	Description	Data
Yes	Refuge 1 Length (In)	37.0	N/A	Gutter 1 Ponding?	N/A
Yes	Refuge 1 Width (In)	119.0	N/A	Gutter 1 Lip Ht (In)	N/A
Yes	Refuge 1 Slope (%)	0.3	N/A	Gutter 1 Slope (%)	N/A
Yes	Refuge 1 X Slope (%)	1.6	N/A	Gutter 1 X Slope (%)	N/A
N/A	Painted X Walk1?	Yes	N/A	DWS 1 Provided?	N/A
N/A	X Walk 1 Direction	To W	N/A	DWS 1 Contrast?	N/A
N/A	X Walk 1 Width (In)	121.0	N/A	DWS 1 Length (In)	N/A
N/A	Road 1 Slope (%)	3.0	N/A	DWS 1 Full Width?	N/A
N/A	Road 1 X Slope (%)	2.0	N/A	DWS 1 Offset (In)	N/A
Yes	Refuge 2 Length (In)	37.0	N/A	Gutter 2 Ponding?	N/A
Yes	Refuge 2 Width (In)	119.0	N/A	Gutter 2 Lip Ht (In)	N/A
Yes	Refuge 2 Slope (%)	0.8	N/A	Gutter 2 Slope (%)	N/A
Yes	Refuge 2 X Slope (%)	2.5	N/A	Gutter 2 X Slope (%)	N/A
N/A	Painted X Walk2?	Yes	N/A	DWS 2 Provided?	N/A
N/A	X Walk 2 Direction	To E	N/A	DWS 2 Contrast?	N/A
N/A	X Walk 2 Width (In)	122.0	N/A	DWS 2 Length (In)	N/A

N/A	Road 2 Slope (%)	3.0	N/A	DWS 2 Full Width?	N/A
N/A	Road 2 X Slope (%)	3.1	N/A	DWS 2 Offset (In)	N/A
N/A	Refuge 3 Length (in)	N/A	N/A	Gutter 3 Ponding?	N/A
N/A	Refuge 3 Width (in)	N/A	N/A	Gutter 3 Lip Ht (in)	N/A
N/A	Refuge 3 Slope (%)	N/A	N/A	Gutter 3 Slope (%)	N/A
N/A	Refuge 3 XSlope (%)	N/A	N/A	Gutter 3 XSlope (%)	N/A
N/A	Painted X Walk3?	N/A	N/A	DWS 3 Provided?	N/A
N/A	X Walk 3 Direction	N/A	N/A	DWS 3 Contrast?	N/A
N/A	X Walk 3 Width (in)	N/A	N/A	DWS 3 Length (in)	N/A
N/A	Road 3 Slope (%)	N/A	N/A	DWS 3 Full Width?	N/A
N/A	Road 3 XSlope (%)	N/A	N/A	DWS 3 Offset (in)	N/A
Yes	Any Obstructions?	N/A	N/A	Storm Grate/Utility Hazard?	N/A
N/A	Obstruction Type		N/A	Storm Grate/Utility Type	
		N/A			N/A
N/A	Surface Condition	Good

Remove & Replace Entire Refuge.
