Access Compliance Report

Public Rights-of-Way

(Island Curb Cuts)

Intersection ID: 10035790	Main Street: REMOUNT_RD	Cross Street: N/A	Location: E
ADA ID: 9CE4B74C334F	Curb Cut Type: MedianRefuge2	Initial Pass/Fail: Fail	Overall Compliance: No
Codes/Mitigation Info/Possible Solution		Field Measurements/Component Compliance	
Severity Score: 1.25

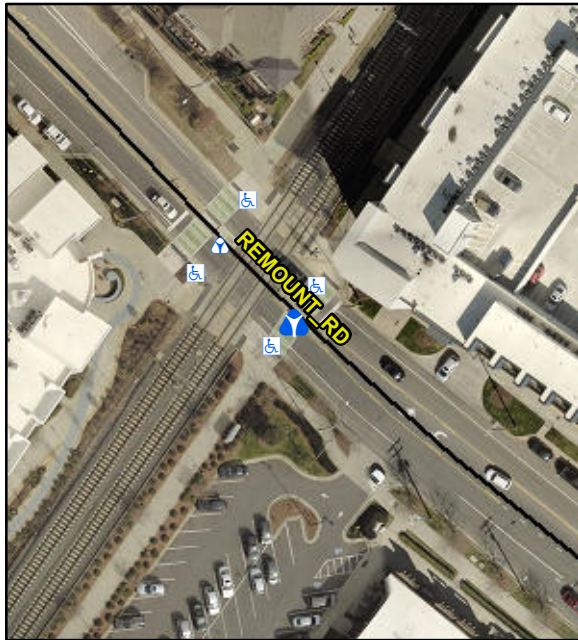
Compliance	Description	Data	Compliance	Description	Data
Yes	Refuge 1 Length (In)	42.0	N/A	Gutter 1 Ponding?	N/A
Yes	Refuge 1 Width (In)	146.0	N/A	Gutter 1 Lip Ht (In)	N/A
Yes	Refuge 1 Slope (%)	2.3	N/A	Gutter 1 Slope (%)	N/A
Yes	Refuge 1 X Slope (%)	3.3	N/A	Gutter 1 X Slope (%)	N/A
N/A	Painted X Walk1?	Yes	N/A	DWS 1 Provided?	N/A
N/A	X Walk 1 Direction	To S	N/A	DWS 1 Contrast?	N/A
N/A	X Walk 1 Width (In)	137.0	N/A	DWS 1 Length (In)	N/A
N/A	Road 1 Slope (%)	2.4	N/A	DWS 1 Full Width?	N/A
N/A	Road 1 X Slope (%)	5.8	N/A	DWS 1 Offset (In)	N/A
Yes	Refuge 2 Length (In)	42.0	N/A	Gutter 2 Ponding?	N/A
Yes	Refuge 2 Width (In)	146.0	N/A	Gutter 2 Lip Ht (In)	N/A
Yes	Refuge 2 Slope (%)	1.4	N/A	Gutter 2 Slope (%)	N/A
Yes	Refuge 2 X Slope (%)	1.6	N/A	Gutter 2 X Slope (%)	N/A
N/A	Painted X Walk2?	Yes	N/A	DWS 2 Provided?	N/A
N/A	X Walk 2 Direction	To N	N/A	DWS 2 Contrast?	N/A
N/A	X Walk 2 Width (In)	136.0	N/A	DWS 2 Length (In)	N/A

N/A	Road 2 Slope (%)	1.4	N/A	DWS 2 Full Width?	N/A
N/A	Road 2 X Slope (%)	1.1	N/A	DWS 2 Offset (In)	N/A
N/A	Refuge 3 Length (in)	N/A	N/A	Gutter 3 Ponding?	N/A
N/A	Refuge 3 Width (in)	N/A	N/A	Gutter 3 Lip Ht (in)	N/A
N/A	Refuge 3 Slope (%)	N/A	N/A	Gutter 3 Slope (%)	N/A
N/A	Refuge 3 XSlope (%)	N/A	N/A	Gutter 3 XSlope (%)	N/A
N/A	Painted X Walk3?	N/A	N/A	DWS 3 Provided?	N/A
N/A	X Walk 3 Direction	N/A	N/A	DWS 3 Contrast?	N/A
N/A	X Walk 3 Width (in)	N/A	N/A	DWS 3 Length (in)	N/A
N/A	Road 3 Slope (%)	N/A	N/A	DWS 3 Full Width?	N/A
N/A	Road 3 XSlope (%)	N/A	N/A	DWS 3 Offset (in)	N/A
Yes	Any Obstructions?	N/A	N/A	Storm Grate/Utility Hazard?	N/A
N/A	Obstruction Type		N/A	Storm Grate/Utility Type	
			N/A		N/A
N/A	Surface Condition	Good

Possible Solutions:

Remove & Replace Entire Refuge.

\$ 3000.00
