Access Compliance Report

Public Rights-of-Way

(Island Curb Cuts)

Intersection ID: 11058	Main Street: N I-77 EXIT 10B_RA	Cross Street: W 5TH_ST	Location: NE
ADA ID: 9D9B25E13BD9	Curb Cut Type: IslandRefuge2	Initial Pass/Fail: Fail	Overall Compliance: No
Codes/Mitigation Info/Possible Solution		Field Measurements/Component Compliance

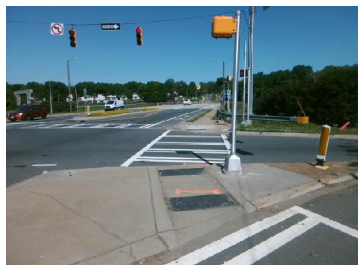
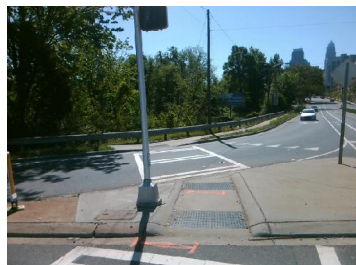
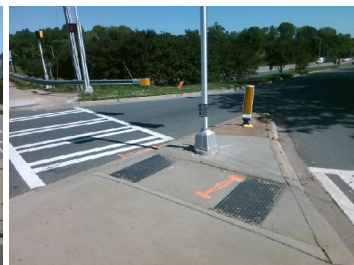
Compliance	Description	Data	Compliance	Description	Data
Yes	Refuge 1 Length (In)	51.0	N/A	Gutter 1 Ponding?	N/A
No	Refuge 1 Width (In)	48.0	N/A	Gutter 1 Lip Ht (In)	N/A
Yes	Refuge 1 Slope (%)	3.6	N/A	Gutter 1 Slope (%)	N/A
Yes	Refuge 1 X Slope (%)	1.1	N/A	Gutter 1 X Slope (%)	N/A
N/A	Painted X Walk1?	Yes	N/A	DWS 1 Provided?	N/A
N/A	X Walk 1 Direction	To N	N/A	DWS 1 Contrast?	N/A
N/A	X Walk 1 Width (In)	113.0	N/A	DWS 1 Length (In)	N/A
N/A	Road 1 Slope (%)	2.3	N/A	DWS 1 Full Width?	N/A
N/A	Road 1 X Slope (%)	0.9	N/A	DWS 1 Offset (In)	N/A
Yes	Refuge 2 Length (In)	51.0	N/A	Gutter 2 Ponding?	N/A
No	Refuge 2 Width (In)	48.0	N/A	Gutter 2 Lip Ht (In)	N/A
Yes	Refuge 2 Slope (%)	0.7	N/A	Gutter 2 Slope (%)	N/A
Yes	Refuge 2 X Slope (%)	0.6	N/A	Gutter 2 X Slope (%)	N/A
N/A	Painted X Walk2?	Yes	N/A	DWS 2 Provided?	N/A
N/A	X Walk 2 Direction	To SE	N/A	DWS 2 Contrast?	N/A
N/A	X Walk 2 Width (In)	110.0	N/A	DWS 2 Length (In)	N/A

N/A	Road 2 Slope (%)	0.7	N/A	DWS 2 Full Width?	N/A
N/A	Road 2 X Slope (%)	2.6	N/A	DWS 2 Offset (In)	N/A
N/A	Refuge 3 Length (in)	N/A	N/A	Gutter 3 Ponding?	N/A
N/A	Refuge 3 Width (in)	N/A	N/A	Gutter 3 Lip Ht (in)	N/A
N/A	Refuge 3 Slope (%)	N/A	N/A	Gutter 3 Slope (%)	N/A
N/A	Refuge 3 XSlope (%)	N/A	N/A	Gutter 3 XSlope (%)	N/A
N/A	Painted X Walk3?	N/A	N/A	DWS 3 Provided?	N/A
N/A	X Walk 3 Direction	N/A	N/A	DWS 3 Contrast?	N/A
N/A	X Walk 3 Width (in)	N/A	N/A	DWS 3 Length (in)	N/A
N/A	Road 3 Slope (%)	N/A	N/A	DWS 3 Full Width?	N/A
N/A	Road 3 XSlope (%)	N/A	N/A	DWS 3 Offset (in)	N/A
Yes	Any Obstructions?	N/A	N/A	Storm Grate/Utility Hazard?	N/A
N/A	Obstruction Type		N/A	Storm Grate/Utility Type	
		N/A			N/A
N/A	Surface Condition	Good

Remove & Replace Entire Refuge.
