Access Compliance Report

Public Rights-of-Way

(Island Curb Cuts)

Intersection ID: 53534	Main Street: N_JOSH_BIRMINGHAM_PY	Cross Street: WILKINSON_BV	Location: NE
ADA ID: 9DF3D080723F	Curb Cut Type: IslandRefuge3	Initial Pass/Fail: Fail	Overall Compliance: No
Codes/Mitigation Info/Possible Solution		Field Measurements/Component Compliance

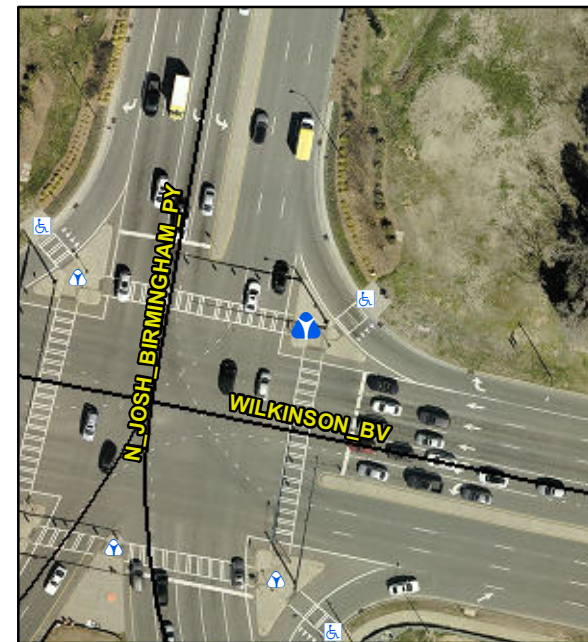
Compliance	Description	Data	Compliance	Description	Data
Yes	Refuge 1 Length (In)	69.0	N/A	Gutter 1 Ponding?	N/A
Yes	Refuge 1 Width (In)	82.0	N/A	Gutter 1 Lip Ht (In)	N/A
Yes	Refuge 1 Slope (%)	2.6	N/A	Gutter 1 Slope (%)	N/A
Yes	Refuge 1 X Slope (%)	2.3	N/A	Gutter 1 X Slope (%)	N/A
N/A	Painted X Walk1?	Yes	N/A	DWS 1 Provided?	N/A
N/A	X Walk 1 Direction	To W	N/A	DWS 1 Contrast?	N/A
N/A	X Walk 1 Width (In)	111.0	N/A	DWS 1 Length (In)	N/A
N/A	Road 1 Slope (%)	2.6	N/A	DWS 1 Full Width?	N/A
N/A	Road 1 X Slope (%)	3.8	N/A	DWS 1 Offset (In)	N/A
Yes	Refuge 2 Length (In)	110.0	N/A	Gutter 2 Ponding?	N/A
Yes	Refuge 2 Width (In)	73.0	N/A	Gutter 2 Lip Ht (In)	N/A
Yes	Refuge 2 Slope (%)	1.5	N/A	Gutter 2 Slope (%)	N/A
Yes	Refuge 2 X Slope (%)	1.0	N/A	Gutter 2 X Slope (%)	N/A
N/A	Painted X Walk2?	Yes	N/A	DWS 2 Provided?	N/A
N/A	X Walk 2 Direction	To S	N/A	DWS 2 Contrast?	N/A
N/A	X Walk 2 Width (In)	111.0	N/A	DWS 2 Length (In)	N/A

N/A	Road 2 Slope (%)	1.7	N/A	DWS 2 Full Width?	N/A
N/A	Road 2 X Slope (%)	1.7	N/A	DWS 2 Offset (In)	N/A
Yes	Refuge 3 Length (in)	92.0	N/A	Gutter 3 Ponding?	N/A
Yes	Refuge 3 Width (in)	116.0	N/A	Gutter 3 Lip Ht (in)	N/A
Yes	Refuge 3 Slope (%)	4.8	N/A	Gutter 3 Slope (%)	N/A
Yes	Refuge 3 XSlope (%)	1.0	N/A	Gutter 3 XSlope (%)	N/A
N/A	Painted X Walk3?	Yes	N/A	DWS 3 Provided?	N/A
N/A	X Walk 3 Direction	To NE	N/A	DWS 3 Contrast?	N/A
N/A	X Walk 3 Width (in)	111.0	N/A	DWS 3 Length (in)	N/A
N/A	Road 3 Slope (%)	0.4	N/A	DWS 3 Full Width?	N/A
N/A	Road 3 XSlope (%)	0.7	N/A	DWS 3 Offset (in)	N/A
Yes	Any Obstructions?	N/A	N/A	Storm Grate/Utility Hazard?	N/A
N/A	Obstruction Type		N/A	Storm Grate/Utility Type	
		N/A			N/A
N/A	Surface Condition	Good

Remove & Replace Entire Refuge.

Total Cost: \$ 3000.00
