Access Compliance Report

Public Rights-of-Way

(Island Curb Cuts)

Intersection ID: 17196	Main Street: IDLEWILD_RD	Cross Street: CONFERENCE_DR	Location: NW
ADA ID: A0B2E1D4E882	Curb Cut Type: IslandRefuge3	Initial Pass/Fail: Fail	Overall Compliance: No
Severity Score: 36.25			
Codes/Mitigation Info/Possible Solution		Field Measurements/Component Compliance

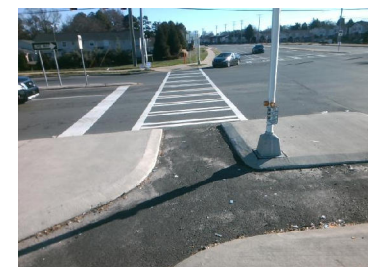
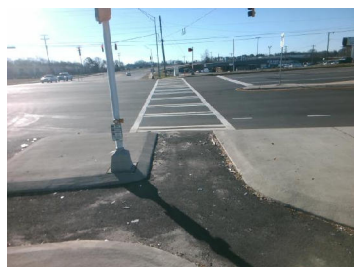
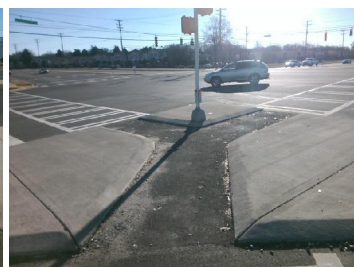
N/A	Road 2 Slope (%)	2.7	N/A	DWS 2 Full Width?	N/A
N/A	Road 2 X Slope (%)	2.7	N/A	DWS 2 Offset (In)	N/A
Yes	Refuge 3 Length (in)	138.0	N/A	Gutter 3 Ponding?	N/A
Yes	Refuge 3 Width (in)	61.0	N/A	Gutter 3 Lip Ht (in)	N/A
Yes	Refuge 3 Slope (%)	1.7	N/A	Gutter 3 Slope (%)	N/A
Yes	Refuge 3 XSlope (%)	4.5	N/A	Gutter 3 XSlope (%)	N/A
N/A	Painted X Walk3?	Yes	N/A	DWS 3 Provided?	N/A
N/A	X Walk 3 Direction	To NW	N/A	DWS 3 Contrast?	N/A
N/A	X Walk 3 Width (in)	110.0	N/A	DWS 3 Length (in)	N/A
N/A	Road 3 Slope (%)	4.2	N/A	DWS 3 Full Width?	N/A
N/A	Road 3 XSlope (%)	0.3	N/A	DWS 3 Offset (in)	N/A
Yes	Any Obstructions?	N/A	N/A	Storm Grate/Utility Hazard?	N/A
N/A	Obstruction Type		N/A	Storm Grate/Utility Type	
		N/A			N/A
N/A	Surface Condition	Good

Possible Solutions:

Remove & Replace Entire Refuge.
