Access Compliance Report

Public Rights-of-Way

(Island Curb Cuts)

Intersection ID: 48168	Main Street: PERIMETER_PY	Cross Street: NORTHLAKE_MALL_DR	Location:	W
ADA ID: A1BEA67A7440	Curb Cut Type: MedianRefuge2	Initial Pass/Fail: Fail	Overall Compliance: No	Severity Score: 0
Codes/Mitigation Info/Possible Solution		Field Measurements/Component Compliance

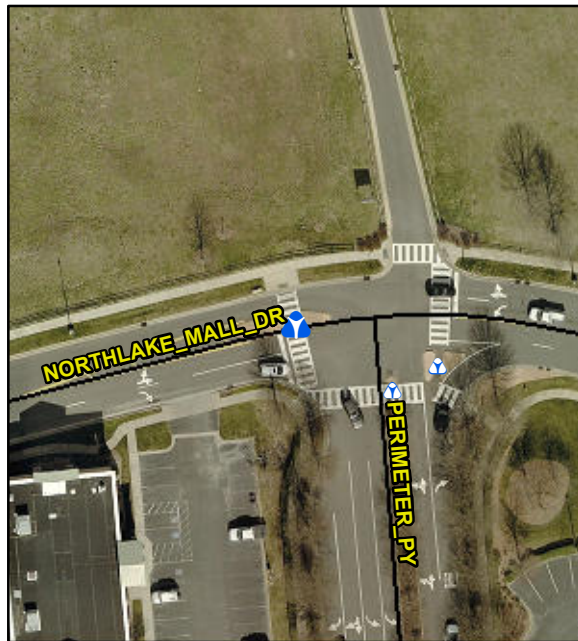
Compliance	Description	Data	Compliance	Description	Data
Yes	Refuge 1 Length (In)	55.0	N/A	Gutter 1 Ponding?	N/A
Yes	Refuge 1 Width (In)	123.0	N/A	Gutter 1 Lip Ht (In)	N/A
Yes	Refuge 1 Slope (%)	1.0	N/A	Gutter 1 Slope (%)	N/A
Yes	Refuge 1 X Slope (%)	1.9	N/A	Gutter 1 X Slope (%)	N/A
N/A	Painted X Walk1?	Yes	N/A	DWS 1 Provided?	N/A
N/A	X Walk 1 Direction	To S	N/A	DWS 1 Contrast?	N/A
N/A	X Walk 1 Width (In)	99.0	N/A	DWS 1 Length (In)	N/A
N/A	Road 1 Slope (%)	3.9	N/A	DWS 1 Full Width?	N/A
N/A	Road 1 X Slope (%)	1.2	N/A	DWS 1 Offset (In)	N/A
Yes	Refuge 2 Length (In)	55.0	N/A	Gutter 2 Ponding?	N/A
Yes	Refuge 2 Width (In)	123.0	N/A	Gutter 2 Lip Ht (In)	N/A
Yes	Refuge 2 Slope (%)	0.6	N/A	Gutter 2 Slope (%)	N/A
Yes	Refuge 2 X Slope (%)	2.1	N/A	Gutter 2 X Slope (%)	N/A
N/A	Painted X Walk2?	Yes	N/A	DWS 2 Provided?	N/A
N/A	X Walk 2 Direction	To N	N/A	DWS 2 Contrast?	N/A
N/A	X Walk 2 Width (In)	99.0	N/A	DWS 2 Length (In)	N/A

N/A	Road 2 Slope (%)	2.0	N/A	DWS 2 Full Width?	N/A
N/A	Road 2 X Slope (%)	3.1	N/A	DWS 2 Offset (In)	N/A
N/A	Refuge 3 Length (in)	N/A	N/A	Gutter 3 Ponding?	N/A
N/A	Refuge 3 Width (in)	N/A	N/A	Gutter 3 Lip Ht (in)	N/A
N/A	Refuge 3 Slope (%)	N/A	N/A	Gutter 3 Slope (%)	N/A
N/A	Refuge 3 XSlope (%)	N/A	N/A	Gutter 3 XSlope (%)	N/A
N/A	Painted X Walk3?	N/A	N/A	DWS 3 Provided?	N/A
N/A	X Walk 3 Direction	N/A	N/A	DWS 3 Contrast?	N/A
N/A	X Walk 3 Width (in)	N/A	N/A	DWS 3 Length (in)	N/A
N/A	Road 3 Slope (%)	N/A	N/A	DWS 3 Full Width?	N/A
N/A	Road 3 XSlope (%)	N/A	N/A	DWS 3 Offset (in)	N/A
Yes	Any Obstructions?	N/A	N/A	Storm Grate/Utility Hazard?	N/A
N/A	Obstruction Type		N/A	Storm Grate/Utility Type	
		N/A			N/A
N/A	Surface Condition	Good

Remove & Replace Entire Refuge.

\$ 3000.00
