Access Compliance Report

Public Rights-of-Way

(Island Curb Cuts)

| Intersection ID: 48492 | Main Street: SHOPTON_RD_WEST | Cross Street: BEREWICK_COMMONS_PY | Location: NE |

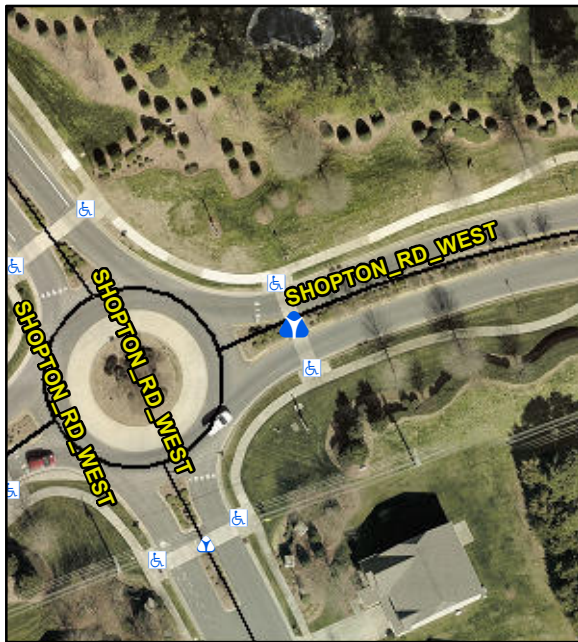
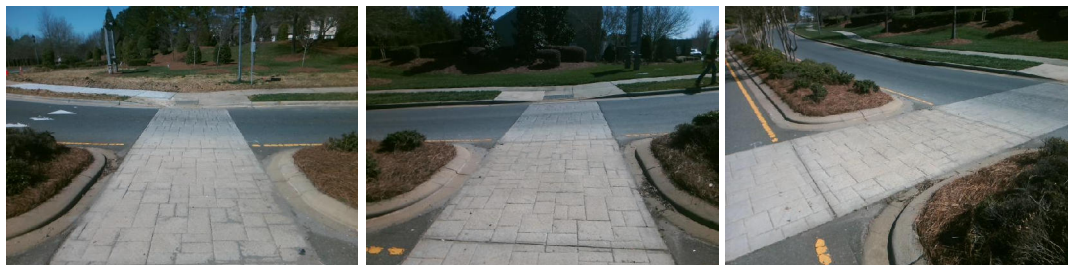
| ADA ID: A1F350E82E2A | Curb Cut Type: MedianRefuge2 | Initial Pass/Fail: Fail | Overall Compliance: No |

Remove & Replace Entire Refuge.
