Access Compliance Report

Public Rights-of-Way

(Island Curb Cuts)

Intersection ID: 32449	Main Street: N_TRYON_ST	Cross Street: J_W_CLAY_BV	Location: E
ADA ID: A3B9BE5891EE	Curb Cut Type: MedianRefuge2	Initial Pass/Fail: Pass	Overall Compliance: No
Severity Score: 35.25			
Codes/Mitigation Info/Possible Solution		Field Measurements/Component Compliance

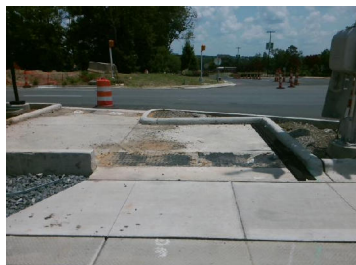
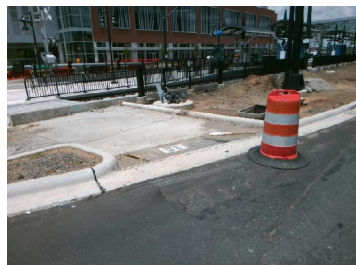
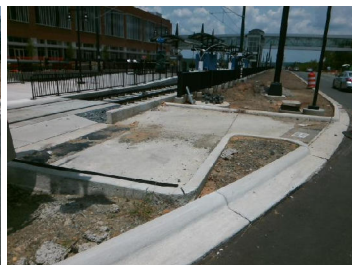
Compliance	Description	Data	Compliance	Description	Data
Yes	Refuge 1 Length (In)	105.0	Yes	Gutter 1 Ponding?	No
Yes	Refuge 1 Width (In)	120.0	Yes	Gutter 1 Lip Ht (In)	0.0
Yes	Refuge 1 Slope (%)	1.9	No	Gutter 1 Slope (%)	5.1
Yes	Refuge 1 X Slope (%)	1.0	Yes	Gutter 1 X Slope (%)	1.1
N/A	Painted X Walk1?	No	Yes	DWS 1 Provided?	Yes
N/A	X Walk 1 Direction	To NW	Yes	DWS 1 Contrast?	Yes
N/A	X Walk 1 Width (In)	N/A	Yes	DWS 1 Length (In)	24.0
N/A	Road 1 Slope (%)	1.2	Yes	DWS 1 Full Width?	Yes
N/A	Road 1 X Slope (%)	0.2	Yes	DWS 1 Offset (In)	1.0
Yes	Refuge 2 Length (In)	64.0	N/A	Gutter 2 Ponding?	No
Yes	Refuge 2 Width (In)	120.0	N/A	Gutter 2 Lip Ht (In)	N/A
Yes	Refuge 2 Slope (%)	2.1	N/A	Gutter 2 Slope (%)	N/A
Yes	Refuge 2 X Slope (%)	1.2	N/A	Gutter 2 X Slope (%)	N/A
N/A	Painted X Walk2?	No	No	DWS 2 Provided?	No
N/A	X Walk 2 Direction	To SE	N/A	DWS 2 Contrast?	No
N/A	X Walk 2 Width (In)	N/A	N/A	DWS 2 Length (In)	N/A

Possible Solutions:

**Install Detectable Warning System.
Remove & Replace Gutter.**
