Access Compliance Report

Public Rights-of-Way

(Island Curb Cuts)

Intersection ID: 43406	Main Street: ARCHDALE_DR	Cross Street: PARK_ROYAL_AV	Location: E
ADA ID: A4DFEA2177B8	Curb Cut Type: MedianRefuge2	Initial Pass/Fail: Fail	Overall Compliance: No
Codes/Mitigation Info/Possible Solution		Field Measurements/Component Compliance

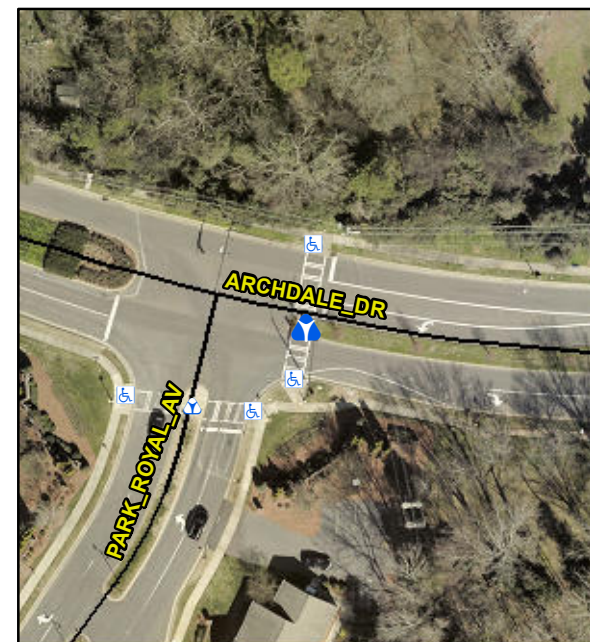
Compliance	Description	Data	Compliance	Description	Data
Yes	Refuge 1 Length (In)	50.5	N/A	Gutter 1 Ponding?	N/A
No	Refuge 1 Width (In)	44.0	N/A	Gutter 1 Lip Ht (In)	N/A
Yes	Refuge 1 Slope (%)	3.8	N/A	Gutter 1 Slope (%)	N/A
Yes	Refuge 1 X Slope (%)	0.2	N/A	Gutter 1 X Slope (%)	N/A
N/A	Painted X Walk1?	Yes	N/A	DWS 1 Provided?	N/A
N/A	X Walk 1 Direction	To S	N/A	DWS 1 Contrast?	N/A
N/A	X Walk 1 Width (In)	115.0	N/A	DWS 1 Length (In)	N/A
N/A	Road 1 Slope (%)	1.1	N/A	DWS 1 Full Width?	N/A
N/A	Road 1 X Slope (%)	2.9	N/A	DWS 1 Offset (In)	N/A
Yes	Refuge 2 Length (In)	50.5	N/A	Gutter 2 Ponding?	N/A
No	Refuge 2 Width (In)	44.0	N/A	Gutter 2 Lip Ht (In)	N/A
Yes	Refuge 2 Slope (%)	3.7	N/A	Gutter 2 Slope (%)	N/A
Yes	Refuge 2 X Slope (%)	1.4	N/A	Gutter 2 X Slope (%)	N/A
N/A	Painted X Walk2?	Yes	N/A	DWS 2 Provided?	N/A
N/A	X Walk 2 Direction	To N	N/A	DWS 2 Contrast?	N/A
N/A	X Walk 2 Width (In)	109.0	N/A	DWS 2 Length (In)	N/A

Possible Solutions:

Remove & Replace Entire Refuge.
