# Access Compliance Report

## Public Rights-of-Way

### (Island Curb Cuts)

Intersection ID: 20146	Main Street: FAIRVIEW_RD	Cross Street: PARK_SOUTH_DR	Location: NW
ADA ID: A575145E8E37	Curb Cut Type: MedianRefuge2	Initial Pass/Fail: Fail	Overall Compliance: No
Codes/Mitigation Info/Possible Solution		Field Measurements/Component Compliance	
Severity Score: 0

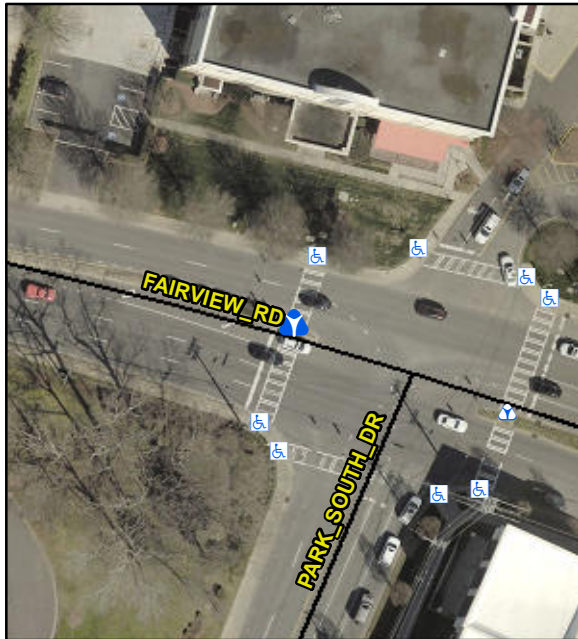
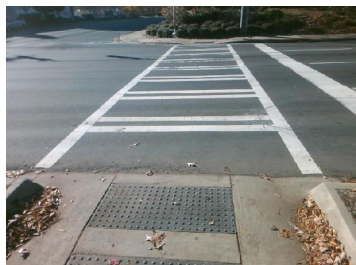
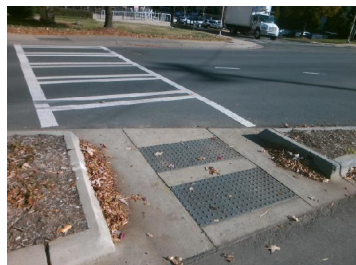
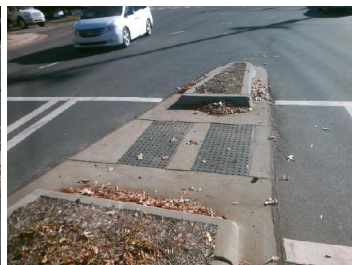
Compliance	Description	Data	Compliance	Description	Data
No	Refuge 1 Length (In)	29.0	N/A	Gutter 1 Ponding?	N/A
Yes	Refuge 1 Width (In)	98.0	N/A	Gutter 1 Lip Ht (In)	N/A
Yes	Refuge 1 Slope (%)	1.4	N/A	Gutter 1 Slope (%)	N/A
Yes	Refuge 1 X Slope (%)	2.1	N/A	Gutter 1 X Slope (%)	N/A
N/A	Painted X Walk1?	Yes	N/A	DWS 1 Provided?	N/A
N/A	X Walk 1 Direction	To SW	N/A	DWS 1 Contrast?	N/A
N/A	X Walk 1 Width (In)	109.0	N/A	DWS 1 Length (In)	N/A
N/A	Road 1 Slope (%)	0.4	N/A	DWS 1 Full Width?	N/A
N/A	Road 1 X Slope (%)	1.9	N/A	DWS 1 Offset (In)	N/A
No	Refuge 2 Length (In)	29.0	N/A	Gutter 2 Ponding?	N/A
Yes	Refuge 2 Width (In)	98.0	N/A	Gutter 2 Lip Ht (In)	N/A
Yes	Refuge 2 Slope (%)	1.0	N/A	Gutter 2 Slope (%)	N/A
Yes	Refuge 2 X Slope (%)	0.6	N/A	Gutter 2 X Slope (%)	N/A
N/A	Painted X Walk2?	Yes	N/A	DWS 2 Provided?	N/A
N/A	X Walk 2 Direction	To NE	N/A	DWS 2 Contrast?	N/A
N/A	X Walk 2 Width (In)	109.0	N/A	DWS 2 Length (In)	N/A

**Remove & Replace Entire Refuge.**

Total Cost: \$ 3000.00
