Access Compliance Report

Public Rights-of-Way

(Island Curb Cuts)

| Intersection ID: 27490 | Main Street: BALLANTYNE_COMMONS_PY | Cross Street: JOHNSTON_RD | Location: | W |

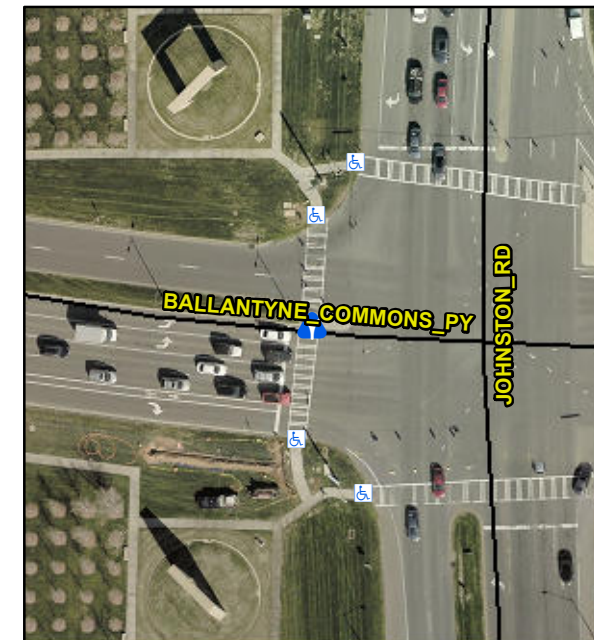
| ADA ID: A74D6E6160A0 | Curb Cut Type: MedianRefuge2 | Initial Pass/Fail: Pass | Overall Compliance: No | Severity Score: 10 |

| Compliance | Description | Data | Compliance | Description | Data |
|---|---|---|---|---|---|
| Yes | Refuge 1 Slope (%) | 1.9 | No | Gutter 1 Slope (%) | 5.9 |
| N/A | Road 1 X Slope (%) | 3.4 | No | DWS 1 Offset (In) | 4.0 |
| N/A | Road 2 X Slope (%) | 3.7 | No | DWS 2 Offset (In) | 4.0 |

Remove & Replace Detectable Warning System. Remove & Replace Gutter.
