Access Compliance Report

Public Rights-of-Way

(Island Curb Cuts)

Intersection ID: 3559	Main Street: PERIMETER_PY	Cross Street: W_W_T_HARRIS_BV	Location: SE
ADA ID: A8675153EDC9	Curb Cut Type: IslandRefuge3	Initial Pass/Fail: Fail	Overall Compliance: No
Codes/Mitigation Info/Possible Solution		Field Measurements/Component Compliance

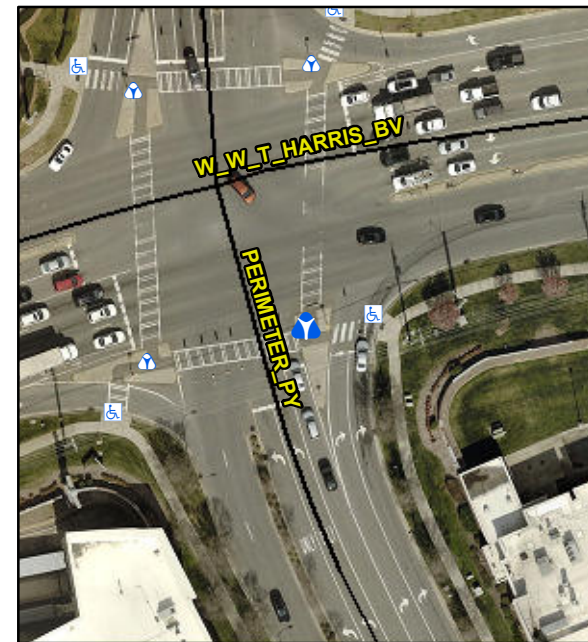
Compliance	Description	Data	Compliance	Description	Data
Yes	Refuge 1 Length (In)	133.0	N/A	Gutter 1 Ponding?	N/A
Yes	Refuge 1 Width (In)	71.0	N/A	Gutter 1 Lip Ht (In)	N/A
Yes	Refuge 1 Slope (%)	3.3	N/A	Gutter 1 Slope (%)	N/A
Yes	Refuge 1 X Slope (%)	2.1	N/A	Gutter 1 X Slope (%)	N/A
N/A	Painted X Walk1?	Yes	N/A	DWS 1 Provided?	N/A
N/A	X Walk 1 Direction	To N	N/A	DWS 1 Contrast?	N/A
N/A	X Walk 1 Width (In)	112.0	N/A	DWS 1 Length (In)	N/A
N/A	Road 1 Slope (%)	2.5	N/A	DWS 1 Full Width?	N/A
N/A	Road 1 X Slope (%)	3.7	N/A	DWS 1 Offset (In)	N/A
Yes	Refuge 2 Length (In)	67.0	N/A	Gutter 2 Ponding?	N/A
Yes	Refuge 2 Width (In)	70.0	N/A	Gutter 2 Lip Ht (In)	N/A
Yes	Refuge 2 Slope (%)	1.3	N/A	Gutter 2 Slope (%)	N/A
Yes	Refuge 2 X Slope (%)	4.7	N/A	Gutter 2 X Slope (%)	N/A
N/A	Painted X Walk2?	Yes	N/A	DWS 2 Provided?	N/A
N/A	X Walk 2 Direction	To SE	N/A	DWS 2 Contrast?	N/A
N/A	X Walk 2 Width (In)	118.0	N/A	DWS 2 Length (In)	N/A

N/A	Road 2 Slope (%)	4.4	N/A	DWS 2 Full Width?	N/A
N/A	Road 2 X Slope (%)	2.6	N/A	DWS 2 Offset (In)	N/A
Yes	Refuge 3 Length (in)	60.0	N/A	Gutter 3 Ponding?	N/A
Yes	Refuge 3 Width (in)	71.0	N/A	Gutter 3 Lip Ht (in)	N/A
Yes	Refuge 3 Slope (%)	4.6	N/A	Gutter 3 Slope (%)	N/A
Yes	Refuge 3 XSlope (%)	4.5	N/A	Gutter 3 XSlope (%)	N/A
N/A	Painted X Walk3?	Yes	N/A	DWS 3 Provided?	N/A
N/A	X Walk 3 Direction	To W	N/A	DWS 3 Contrast?	N/A
N/A	X Walk 3 Width (in)	108.0	N/A	DWS 3 Length (in)	N/A
N/A	Road 3 Slope (%)	3.4	N/A	DWS 3 Full Width?	N/A
N/A	Road 3 XSlope (%)	4.6	N/A	DWS 3 Offset (in)	N/A
Yes	Any Obstructions?	N/A	N/A	Storm Grate/Utility Hazard?	N/A
N/A	Obstruction Type		N/A	Storm Grate/Utility Type	
		N/A			N/A
N/A	Surface Condition	Good

Possible Solutions:

Remove & Replace Entire Refuge.
