# Access Compliance Report

## Public Rights-of-Way

### (Island Curb Cuts)

Intersection ID: 51054	Main Street: MULBERRY_CHURCH_RD	Cross Street: WESTPORT_RD	Location: NW
ADA ID: AAC348FDC741	Curb Cut Type: MedianRefuge2	Initial Pass/Fail: Fail	Overall Compliance: No
Codes/Mitigation Info/Possible Solution		Field Measurements/Component Compliance	
Severity Score: 12.5

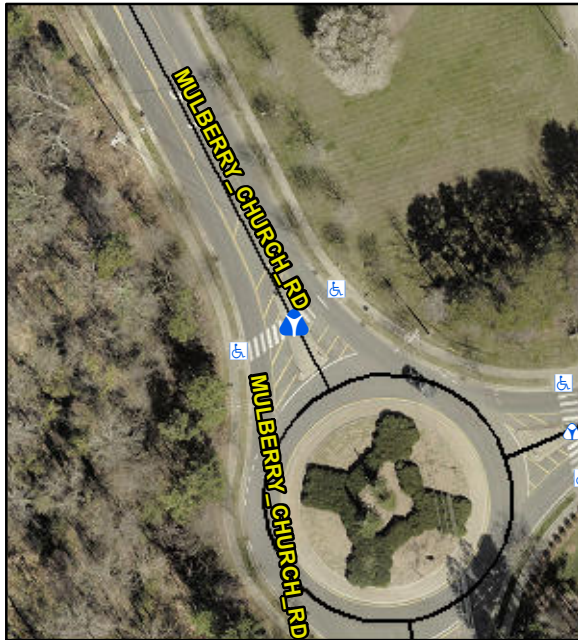
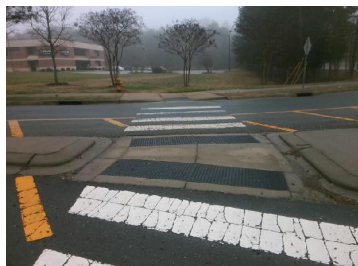
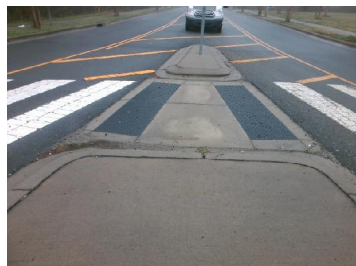
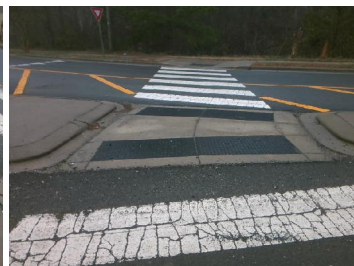
Compliance	Description	Data	Compliance	Description	Data
No	Refuge 1 Length (In)	25.5	N/A	Gutter 1 Ponding?	N/A
Yes	Refuge 1 Width (In)	135.5	N/A	Gutter 1 Lip Ht (In)	N/A
Yes	Refuge 1 Slope (%)	0.9	N/A	Gutter 1 Slope (%)	N/A
No	Refuge 1 X Slope (%)	5.2	N/A	Gutter 1 X Slope (%)	N/A
N/A	Painted X Walk1?	Yes	N/A	DWS 1 Provided?	N/A
N/A	X Walk 1 Direction	To W	N/A	DWS 1 Contrast?	N/A
N/A	X Walk 1 Width (In)	121.0	N/A	DWS 1 Length (In)	N/A
N/A	Road 1 Slope (%)	2.2	N/A	DWS 1 Full Width?	N/A
N/A	Road 1 X Slope (%)	0.4	N/A	DWS 1 Offset (In)	N/A
No	Refuge 2 Length (In)	25.0	N/A	Gutter 2 Ponding?	N/A
Yes	Refuge 2 Width (In)	135.5	N/A	Gutter 2 Lip Ht (In)	N/A
Yes	Refuge 2 Slope (%)	0.6	N/A	Gutter 2 Slope (%)	N/A
Yes	Refuge 2 X Slope (%)	3.5	N/A	Gutter 2 X Slope (%)	N/A
N/A	Painted X Walk2?	Yes	N/A	DWS 2 Provided?	N/A
N/A	X Walk 2 Direction	To E	N/A	DWS 2 Contrast?	N/A
N/A	X Walk 2 Width (In)	116.0	N/A	DWS 2 Length (In)	N/A

**Remove & Replace Entire Refuge.**
