Access Compliance Report

Public Rights-of-Way

(Island Curb Cuts)

| Intersection ID: 28389 | Main Street: ARDREY_KELL_RD | Cross Street: LANCASTER_HY | Location: SW |

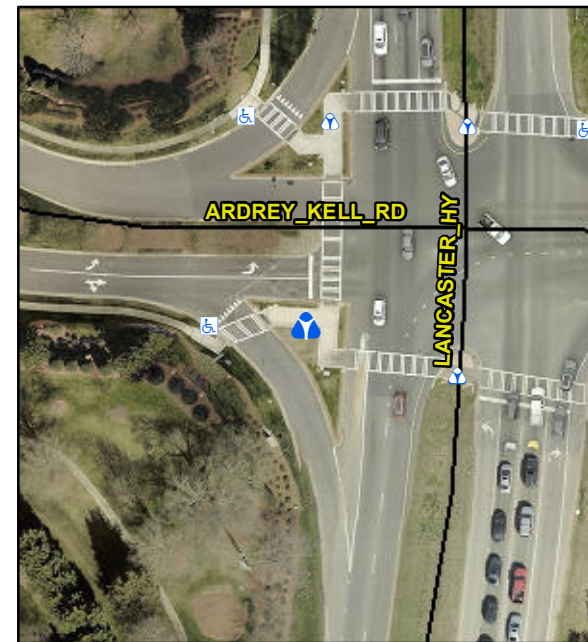
| ADA ID: AB357F0E0B91 | Curb Cut Type: IslandRefuge3 | Initial Pass/Fail: Fail | Overall Compliance: No |

Possible Solutions:

Remove & Replace Entire Refuge.
