Access Compliance Report

Public Rights-of-Way

(Island Curb Cuts)

Intersection ID: 53763	Main Street: COMMUNITY_COMMONS_LN	Cross Street: NORTH_COMMUNITY_HOUSE_RD	Location: NE
ADA ID: AB48F9974379	Curb Cut Type: MedianRefuge2	Initial Pass/Fail: Fail	Overall Compliance: No
Codes/Mitigation Info/Possible Solution		Field Measurements/Component Compliance	
Severity Score: 0

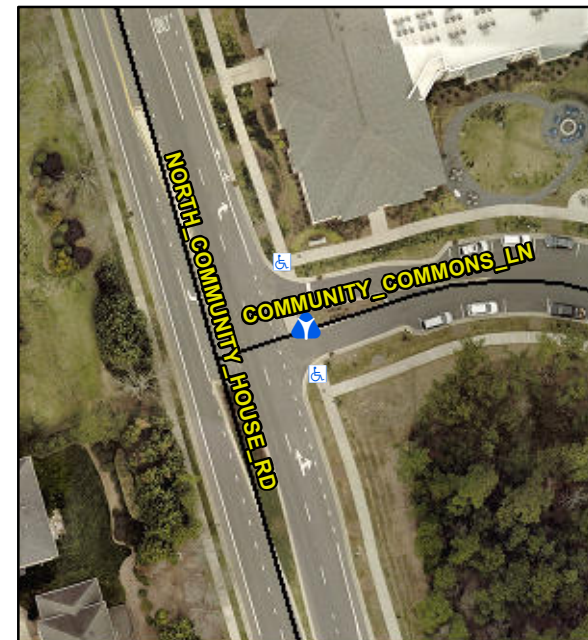
Compliance	Description	Data	Compliance	Description	Data
Yes	Refuge 1 Length (In)	64.0	N/A	Gutter 1 Ponding?	N/A
Yes	Refuge 1 Width (In)	66.0	N/A	Gutter 1 Lip Ht (In)	N/A
Yes	Refuge 1 Slope (%)	1.1	N/A	Gutter 1 Slope (%)	N/A
Yes	Refuge 1 X Slope (%)	2.7	N/A	Gutter 1 X Slope (%)	N/A
N/A	Painted X Walk1?	No	N/A	DWS 1 Provided?	N/A
N/A	X Walk 1 Direction	To NW	N/A	DWS 1 Contrast?	N/A
N/A	X Walk 1 Width (In)	N/A	N/A	DWS 1 Length (In)	N/A
N/A	Road 1 Slope (%)	1.6	N/A	DWS 1 Full Width?	N/A
N/A	Road 1 X Slope (%)	0.8	N/A	DWS 1 Offset (In)	N/A
Yes	Refuge 2 Length (In)	64.0	N/A	Gutter 2 Ponding?	N/A
Yes	Refuge 2 Width (In)	66.0	N/A	Gutter 2 Lip Ht (In)	N/A
Yes	Refuge 2 Slope (%)	1.7	N/A	Gutter 2 Slope (%)	N/A
Yes	Refuge 2 X Slope (%)	3.6	N/A	Gutter 2 X Slope (%)	N/A
N/A	Painted X Walk2?	No	N/A	DWS 2 Provided?	N/A
N/A	X Walk 2 Direction	To SE	N/A	DWS 2 Contrast?	N/A
N/A	X Walk 2 Width (In)	N/A	N/A	DWS 2 Length (In)	N/A

N/A	Road 2 Slope (%)	1.9	N/A	DWS 2 Full Width?	N/A
N/A	Road 2 X Slope (%)	0.9	N/A	DWS 2 Offset (In)	N/A
N/A	Refuge 3 Length (in)	N/A	N/A	Gutter 3 Ponding?	N/A
N/A	Refuge 3 Width (in)	N/A	N/A	Gutter 3 Lip Ht (in)	N/A
N/A	Refuge 3 Slope (%)	N/A	N/A	Gutter 3 Slope (%)	N/A
N/A	Refuge 3 XSlope (%)	N/A	N/A	Gutter 3 XSlope (%)	N/A
N/A	Painted X Walk3?	N/A	N/A	DWS 3 Provided?	N/A
N/A	X Walk 3 Direction	N/A	N/A	DWS 3 Contrast?	N/A
N/A	X Walk 3 Width (in)	N/A	N/A	DWS 3 Length (in)	N/A
N/A	Road 3 Slope (%)	N/A	N/A	DWS 3 Full Width?	N/A
N/A	Road 3 XSlope (%)	N/A	N/A	DWS 3 Offset (in)	N/A
Yes	Any Obstructions?	N/A	N/A	Storm Grate/Utility Hazard?	N/A
N/A	Obstruction Type		N/A	Storm Grate/Utility Type	
		N/A			N/A
N/A	Surface Condition	Good

Possible Solutions:

Remove & Replace Entire Refuge.
