Access Compliance Report

Public Rights-of-Way

(Island Curb Cuts)

Intersection ID: 53488	Main Street: WAVERLY_WALK_AV	Cross Street: N/A	Location: W
ADA ID: AB8D3FFF1A28	Curb Cut Type: MedianRefuge2	Initial Pass/Fail: Fail	Overall Compliance: No
Codes/Mitigation Info/Possible Solution		Field Measurements/Component Compliance	
Severity Score: 1.25

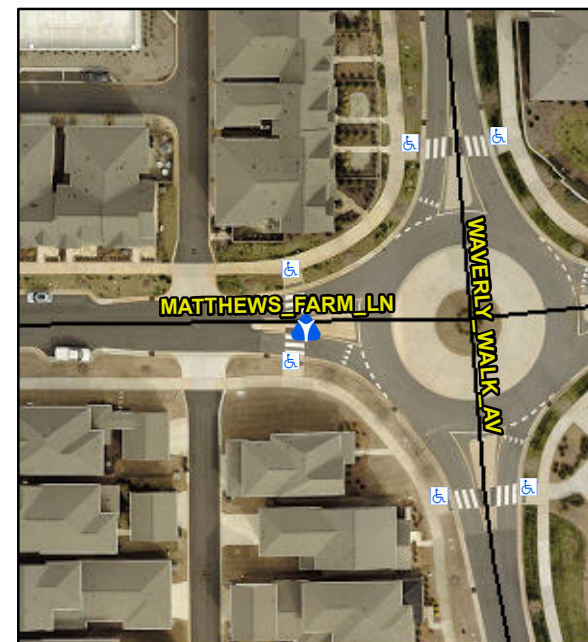
Compliance	Description	Data	Compliance	Description	Data
Yes	Refuge 1 Length (In)	37.0	N/A	Gutter 1 Ponding?	N/A
Yes	Refuge 1 Width (In)	120.0	N/A	Gutter 1 Lip Ht (In)	N/A
Yes	Refuge 1 Slope (%)	3.5	N/A	Gutter 1 Slope (%)	N/A
Yes	Refuge 1 X Slope (%)	3.4	N/A	Gutter 1 X Slope (%)	N/A
N/A	Painted X Walk1?	Yes	N/A	DWS 1 Provided?	N/A
N/A	X Walk 1 Direction	To S	N/A	DWS 1 Contrast?	N/A
N/A	X Walk 1 Width (In)	121.0	N/A	DWS 1 Length (In)	N/A
N/A	Road 1 Slope (%)	2.7	N/A	DWS 1 Full Width?	N/A
N/A	Road 1 X Slope (%)	4.9	N/A	DWS 1 Offset (In)	N/A
Yes	Refuge 2 Length (In)	37.0	N/A	Gutter 2 Ponding?	N/A
Yes	Refuge 2 Width (In)	120.0	N/A	Gutter 2 Lip Ht (In)	N/A
Yes	Refuge 2 Slope (%)	4.5	N/A	Gutter 2 Slope (%)	N/A
Yes	Refuge 2 X Slope (%)	3.1	N/A	Gutter 2 X Slope (%)	N/A
N/A	Painted X Walk2?	Yes	N/A	DWS 2 Provided?	N/A
N/A	X Walk 2 Direction	To N	N/A	DWS 2 Contrast?	N/A
N/A	X Walk 2 Width (In)	121.0	N/A	DWS 2 Length (In)	N/A

N/A	Road 2 Slope (%)	1.4	N/A	DWS 2 Full Width?	N/A
N/A	Road 2 X Slope (%)	0.6	N/A	DWS 2 Offset (In)	N/A
N/A	Refuge 3 Length (in)	N/A	N/A	Gutter 3 Ponding?	N/A
N/A	Refuge 3 Width (in)	N/A	N/A	Gutter 3 Lip Ht (in)	N/A
N/A	Refuge 3 Slope (%)	N/A	N/A	Gutter 3 Slope (%)	N/A
N/A	Refuge 3 XSlope (%)	N/A	N/A	Gutter 3 XSlope (%)	N/A
N/A	Painted X Walk3?	N/A	N/A	DWS 3 Provided?	N/A
N/A	X Walk 3 Direction	N/A	N/A	DWS 3 Contrast?	N/A
N/A	X Walk 3 Width (in)	N/A	N/A	DWS 3 Length (in)	N/A
N/A	Road 3 Slope (%)	N/A	N/A	DWS 3 Full Width?	N/A
N/A	Road 3 XSlope (%)	N/A	N/A	DWS 3 Offset (in)	N/A
Yes	Any Obstructions?	N/A	N/A	Storm Grate/Utility Hazard?	N/A
N/A	Obstruction Type		N/A	Storm Grate/Utility Type	
		N/A			N/A
N/A	Surface Condition	Good

Possible Solutions:

Remove & Replace Entire Refuge.
