Access Compliance Report

Public Rights-of-Way

(Island Curb Cuts)

Intersection ID: 14091	Main Street: E_7TH_ST	Cross Street: N_CASWELL_RD	Location: NW
ADA ID: AB9689C72EBF	Curb Cut Type: MedianRefuge2	Initial Pass/Fail: Fail	Overall Compliance: No
Severity Score: 12.5			
Codes/Mitigation Info/Possible Solution		Field Measurements/Component Compliance

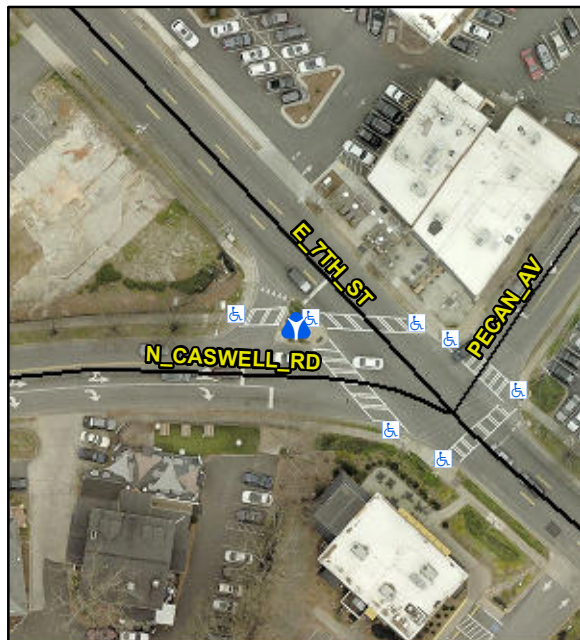
**#3 WAS COLLECTED SEPARATELY
AS PERPENDICULAR RAMP**

Remove & Replace Entire Refuge.
