# Access Compliance Report

## Public Rights-of-Way

### (Island Curb Cuts)

Intersection ID: 8739	Main Street: N_TRYON_ST	Cross Street: W_EASTWAY_DR	Location:	SW
ADA ID: AC14DFA9C5CF	Curb Cut Type: IslandRefuge2	Initial Pass/Fail: Pass	Overall Compliance: No	Severity Score: 7.5
Codes/Mitigation Info/Possible Solution		Field Measurements/Component Compliance

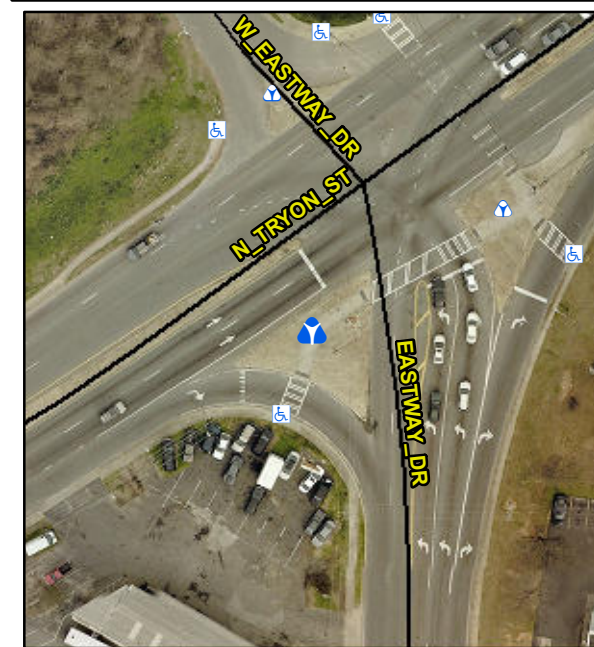
Compliance	Description	Data	Compliance	Description	Data
Yes	Refuge 1 Length (In)	363.5	Yes	Gutter 1 Ponding?	No
Yes	Refuge 1 Width (In)	92.0	No	Gutter 1 Lip Ht (In)	0.5
Yes	Refuge 1 Slope (%)	0.9	Yes	Gutter 1 Slope (%)	0.0
Yes	Refuge 1 X Slope (%)	1.1	Yes	Gutter 1 X Slope (%)	0.7
N/A	Painted X Walk1?	Yes	Yes	DWS 1 Provided?	Yes
N/A	X Walk 1 Direction	To NE	Yes	DWS 1 Contrast?	Yes
N/A	X Walk 1 Width (In)	104.5	Yes	DWS 1 Length (In)	24.0
N/A	Road 1 Slope (%)	1.3	Yes	DWS 1 Full Width?	Yes
N/A	Road 1 X Slope (%)	1.5	Yes	DWS 1 Offset (In)	0.0
Yes	Refuge 2 Length (In)	280.0	Yes	Gutter 2 Ponding?	No
Yes	Refuge 2 Width (In)	91.5	Yes	Gutter 2 Lip Ht (In)	0.0
Yes	Refuge 2 Slope (%)	1.3	Yes	Gutter 2 Slope (%)	2.4
Yes	Refuge 2 X Slope (%)	1.4	Yes	Gutter 2 X Slope (%)	3.4
N/A	Painted X Walk2?	Yes	Yes	DWS 2 Provided?	Yes
N/A	X Walk 2 Direction	To SW	Yes	DWS 2 Contrast?	Yes
N/A	X Walk 2 Width (In)	109.0	Yes	DWS 2 Length (In)	24.0

**Grind Gutter Lip. Utility Present.**

Total Cost: \$ 5200.00
