Access Compliance Report

Public Rights-of-Way

(Island Curb Cuts)

| Intersection ID: 10031842 | Main Street: MINTWORTH_AV | Cross Street: N/A | Location: E |

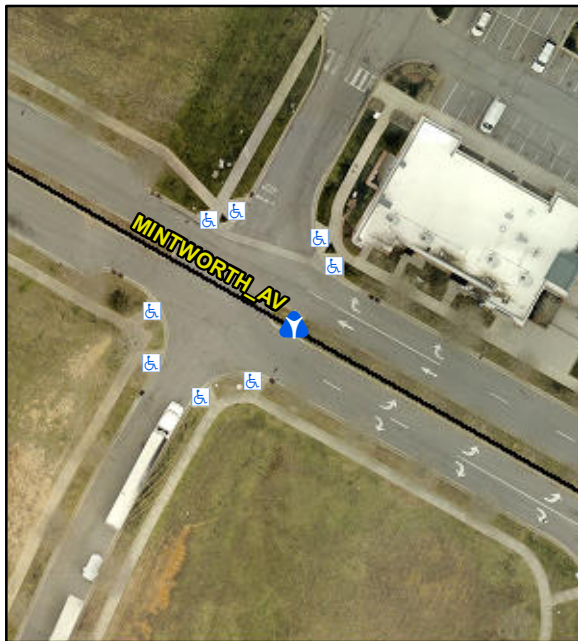
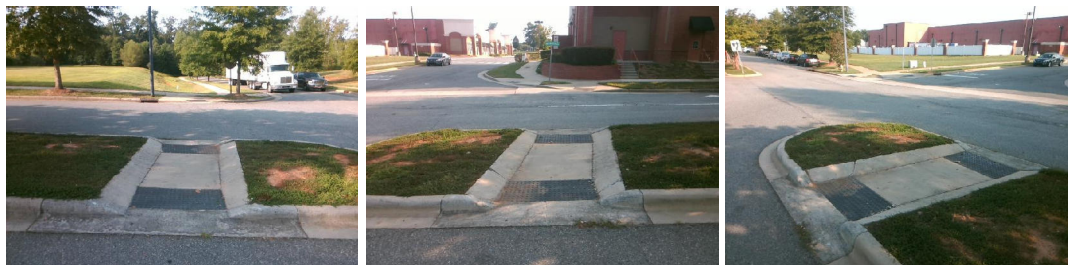
| ADA ID: AC17C560A623 | Curb Cut Type: MedianRefuge2 | Initial Pass/Fail: Fail | Overall Compliance: No |
| Severity Score: 30 | | | |

| Compliance | Description | Data | Compliance | Description | Data |
|---|---|---|---|---|---|
| No | Refuge 1 Width (In) | 47.5 | N/A | Gutter 1 Lip Ht (In) | N/A |
| No | Refuge 1 X Slope (%) | 6.0 | N/A | Gutter 1 X Slope (%) | N/A |
| No | Refuge 2 Width (In) | 47.5 | N/A | Gutter 2 Lip Ht (In) | N/A |
| No | Refuge 2 X Slope (%) | 5.3 | N/A | Gutter 2 X Slope (%) | N/A |

Remove & Replace Entire Refuge.

\$ 3000.00
