Access Compliance Report

Public Rights-of-Way

(Island Curb Cuts)

Intersection ID: 11153	Main Street: E_W_T_HARRIS_BV	Cross Street: N_SHARON_AMITY_RD	Location: SW
ADA ID: AC7F3B78B825	Curb Cut Type: IslandRefuge3	Initial Pass/Fail: Fail	Overall Compliance: No
Codes/Mitigation Info/Possible Solution		Field Measurements/Component Compliance

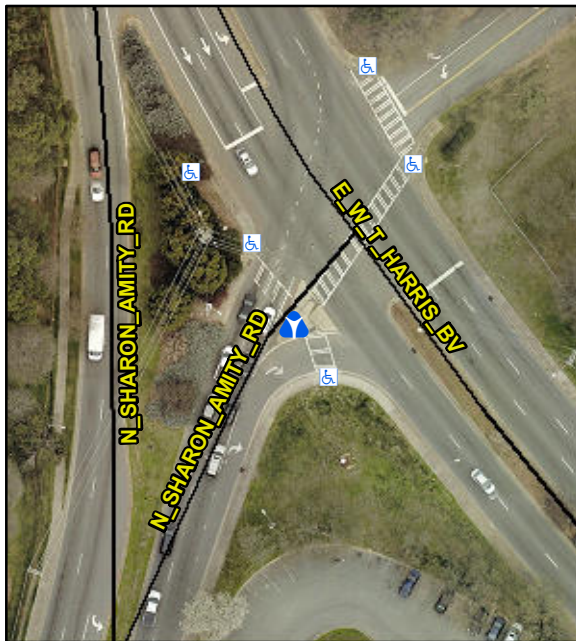
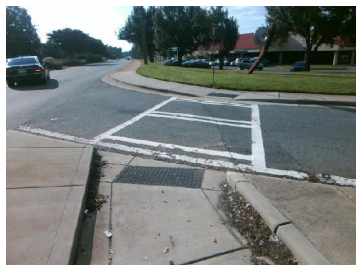
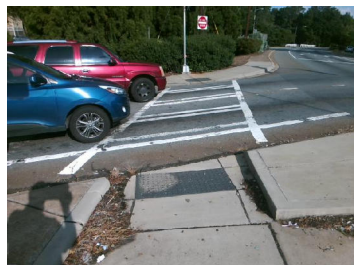
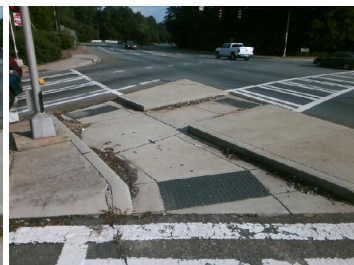
Compliance	Description	Data	Compliance	Description	Data
Yes	Refuge 1 Length (In)	63.0	N/A	Gutter 1 Ponding?	N/A
Yes	Refuge 1 Width (In)	70.0	N/A	Gutter 1 Lip Ht (In)	N/A
Yes	Refuge 1 Slope (%)	1.1	N/A	Gutter 1 Slope (%)	N/A
Yes	Refuge 1 X Slope (%)	2.6	N/A	Gutter 1 X Slope (%)	N/A
N/A	Painted X Walk1?	Yes	N/A	DWS 1 Provided?	N/A
N/A	X Walk 1 Direction	To SE	N/A	DWS 1 Contrast?	N/A
N/A	X Walk 1 Width (In)	112.0	N/A	DWS 1 Length (In)	N/A
N/A	Road 1 Slope (%)	3.3	N/A	DWS 1 Full Width?	N/A
N/A	Road 1 X Slope (%)	0.9	N/A	DWS 1 Offset (In)	N/A
Yes	Refuge 2 Length (In)	50.0	N/A	Gutter 2 Ponding?	N/A
Yes	Refuge 2 Width (In)	71.5	N/A	Gutter 2 Lip Ht (In)	N/A
Yes	Refuge 2 Slope (%)	3.8	N/A	Gutter 2 Slope (%)	N/A
Yes	Refuge 2 X Slope (%)	2.4	N/A	Gutter 2 X Slope (%)	N/A
N/A	Painted X Walk2?	Yes	N/A	DWS 2 Provided?	N/A
N/A	X Walk 2 Direction	To NW	N/A	DWS 2 Contrast?	N/A
N/A	X Walk 2 Width (In)	116.0	N/A	DWS 2 Length (In)	N/A

N/A	Road 2 Slope (%)	3.2	N/A	DWS 2 Full Width?	N/A
N/A	Road 2 X Slope (%)	4.5	N/A	DWS 2 Offset (In)	N/A
Yes	Refuge 3 Length (in)	118.0	N/A	Gutter 3 Ponding?	N/A
Yes	Refuge 3 Width (in)	72.0	N/A	Gutter 3 Lip Ht (in)	N/A
Yes	Refuge 3 Slope (%)	4.3	N/A	Gutter 3 Slope (%)	N/A
Yes	Refuge 3 XSlope (%)	0.4	N/A	Gutter 3 XSlope (%)	N/A
N/A	Painted X Walk3?	Yes	N/A	DWS 3 Provided?	N/A
N/A	X Walk 3 Direction	To NE	N/A	DWS 3 Contrast?	N/A
N/A	X Walk 3 Width (in)	105.0	N/A	DWS 3 Length (in)	N/A
N/A	Road 3 Slope (%)	1.4	N/A	DWS 3 Full Width?	N/A
N/A	Road 3 XSlope (%)	1.7	N/A	DWS 3 Offset (in)	N/A
Yes	Any Obstructions?	N/A	N/A	Storm Grate/Utility Hazard?	N/A
N/A	Obstruction Type		N/A	Storm Grate/Utility Type	
		N/A			N/A
N/A	Surface Condition	Good

Remove & Replace Entire Refuge.
