# Access Compliance Report

## Public Rights-of-Way

### (Island Curb Cuts)

| Intersection ID: 13936 | Main Street: S_KINGS_DR | Cross Street: CHARLOTTETOWNE_AV | Location: SW |

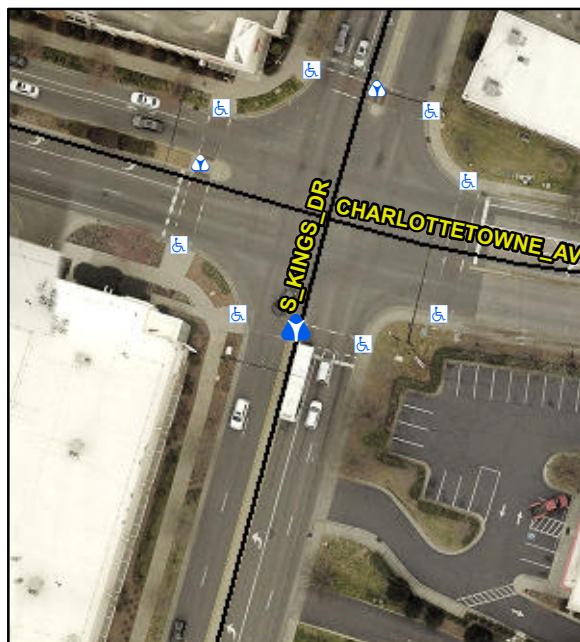
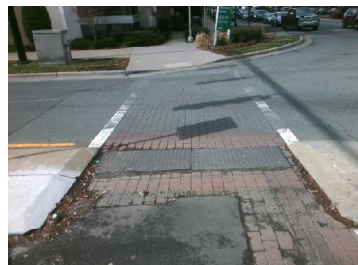
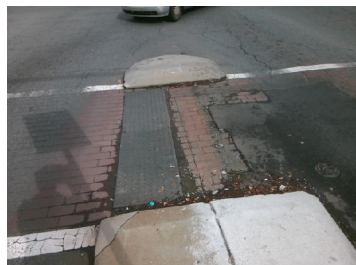
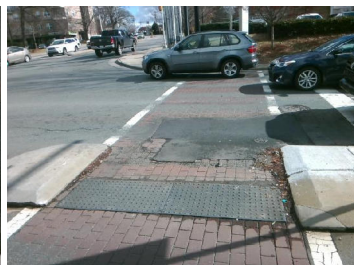
| ADA ID: AD68DC99EC43 | Curb Cut Type: MedianRefuge2 | Initial Pass/Fail: Fail | Overall Compliance: No |

| Compliance | Description | Data | Compliance | Description | Data |
|---|---|---|---|---|---|
| No | Refuge 1 Length (In) | 33.5 | N/A | Gutter 1 Ponding? | N/A |
| No | Refuge 1 Slope (%) | 6.7 | N/A | Gutter 1 Slope (%) | N/A |
| No | Refuge 2 Length (In) | 33.5 | N/A | Gutter 2 Ponding? | N/A |
| No | Refuge 2 Slope (%) | 5.8 | N/A | Gutter 2 Slope (%) | N/A |

**Remove & Replace Entire Refuge.**
