Access Compliance Report

Public Rights-of-Way

(Island Curb Cuts)

| Intersection ID: 23558 | Main Street: HAMLIN_PARK_DR | Cross Street: PARK_RD | Location: NE |

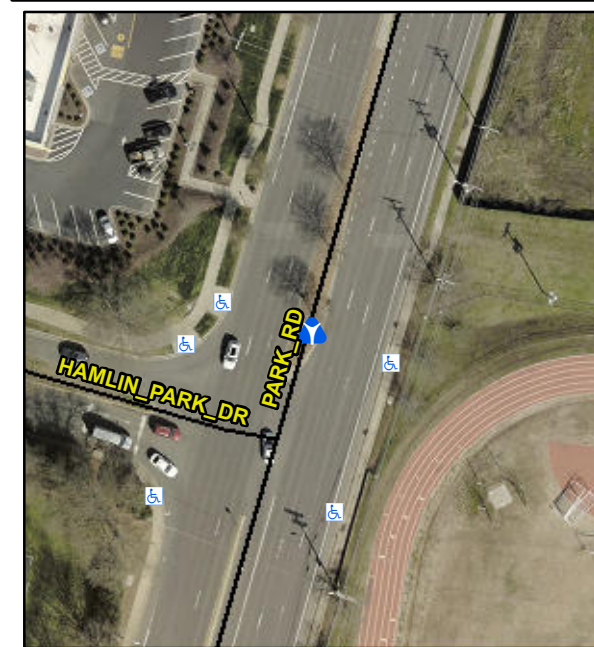
| ADA ID: AE1D3224F0B3 | Curb Cut Type: MedianRefuge2 | Initial Pass/Fail: Fail | Overall Compliance: No |

Remove & Replace Entire Refuge.

\$ 3000.00
