Access Compliance Report

Public Rights-of-Way

(Island Curb Cuts)

Intersection ID: 14267	Main Street: CLANTON_RD	Cross Street: FARMER_ST	Location: N
ADA ID: B0AF5CEE9956	Curb Cut Type: MedianRefuge2	Initial Pass/Fail: Fail	Overall Compliance: No
Severity Score: 0			
Codes/Mitigation Info/Possible Solution		Field Measurements/Component Compliance

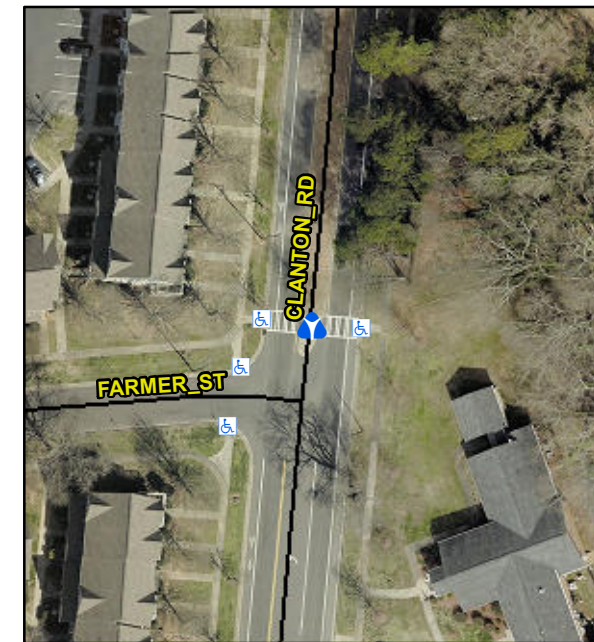
Compliance	Description	Data	Compliance	Description	Data
Yes	Refuge 1 Length (In)	64.0	N/A	Gutter 1 Ponding?	N/A
Yes	Refuge 1 Width (In)	99.0	N/A	Gutter 1 Lip Ht (In)	N/A
Yes	Refuge 1 Slope (%)	0.8	N/A	Gutter 1 Slope (%)	N/A
Yes	Refuge 1 X Slope (%)	3.8	N/A	Gutter 1 X Slope (%)	N/A
N/A	Painted X Walk1?	Yes	N/A	DWS 1 Provided?	N/A
N/A	X Walk 1 Direction	To E	N/A	DWS 1 Contrast?	N/A
N/A	X Walk 1 Width (In)	116.0	N/A	DWS 1 Length (In)	N/A
N/A	Road 1 Slope (%)	4.7	N/A	DWS 1 Full Width?	N/A
N/A	Road 1 X Slope (%)	3.2	N/A	DWS 1 Offset (In)	N/A
Yes	Refuge 2 Length (In)	64.0	N/A	Gutter 2 Ponding?	N/A
Yes	Refuge 2 Width (In)	99.0	N/A	Gutter 2 Lip Ht (In)	N/A
Yes	Refuge 2 Slope (%)	1.0	N/A	Gutter 2 Slope (%)	N/A
Yes	Refuge 2 X Slope (%)	5.0	N/A	Gutter 2 X Slope (%)	N/A
N/A	Painted X Walk2?	Yes	N/A	DWS 2 Provided?	N/A
N/A	X Walk 2 Direction	To W	N/A	DWS 2 Contrast?	N/A
N/A	X Walk 2 Width (In)	118.0	N/A	DWS 2 Length (In)	N/A

N/A	Road 2 Slope (%)	5.2	N/A	DWS 2 Full Width?	N/A
N/A	Road 2 X Slope (%)	3.1	N/A	DWS 2 Offset (In)	N/A
N/A	Refuge 3 Length (in)	N/A	N/A	Gutter 3 Ponding?	N/A
N/A	Refuge 3 Width (in)	N/A	N/A	Gutter 3 Lip Ht (in)	N/A
N/A	Refuge 3 Slope (%)	N/A	N/A	Gutter 3 Slope (%)	N/A
N/A	Refuge 3 XSlope (%)	N/A	N/A	Gutter 3 XSlope (%)	N/A
N/A	Painted X Walk3?	N/A	N/A	DWS 3 Provided?	N/A
N/A	X Walk 3 Direction	N/A	N/A	DWS 3 Contrast?	N/A
N/A	X Walk 3 Width (in)	N/A	N/A	DWS 3 Length (in)	N/A
N/A	Road 3 Slope (%)	N/A	N/A	DWS 3 Full Width?	N/A
N/A	Road 3 XSlope (%)	N/A	N/A	DWS 3 Offset (in)	N/A
Yes	Any Obstructions?	N/A	N/A	Storm Grate/Utility Hazard?	N/A
N/A	Obstruction Type		N/A	Storm Grate/Utility Type	
		N/A			N/A
N/A	Surface Condition	Good

Possible Solutions:

Remove & Replace Entire Refuge.

Total Cost: \$ 3000.00
