# Access Compliance Report

## Public Rights-of-Way

### (Island Curb Cuts)

Intersection ID: 29339	Main Street: NEVIN_BROOK_RD	Cross Street: NEVIN_RD	Location: SW
ADA ID: B14A2AD33EEF	Curb Cut Type: MedianRefuge2	Initial Pass/Fail: Fail	Overall Compliance: No
Codes/Mitigation Info/Possible Solution		Field Measurements/Component Compliance

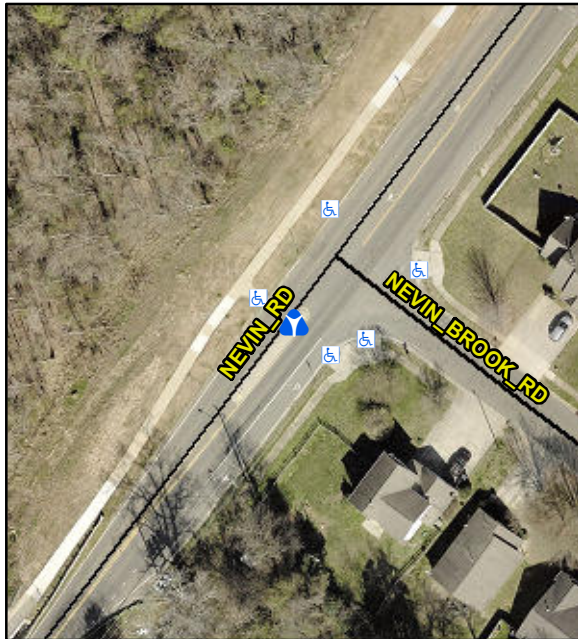
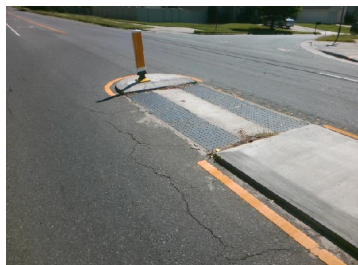
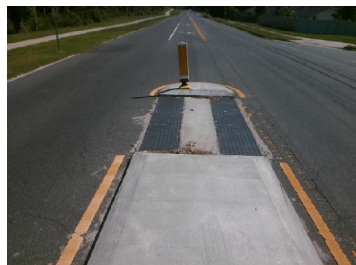
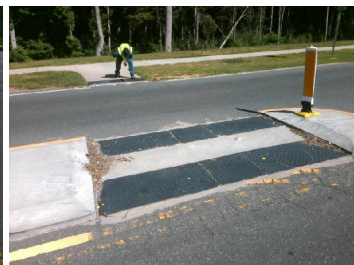
Compliance	Description	Data	Compliance	Description	Data
Yes	Refuge 1 Length (In)	36.0	N/A	Gutter 1 Ponding?	N/A
Yes	Refuge 1 Width (In)	119.0	N/A	Gutter 1 Lip Ht (In)	N/A
Yes	Refuge 1 Slope (%)	1.7	N/A	Gutter 1 Slope (%)	N/A
Yes	Refuge 1 X Slope (%)	3.6	N/A	Gutter 1 X Slope (%)	N/A
N/A	Painted X Walk1?	No	N/A	DWS 1 Provided?	N/A
N/A	X Walk 1 Direction	To SE	N/A	DWS 1 Contrast?	N/A
N/A	X Walk 1 Width (In)	N/A	N/A	DWS 1 Length (In)	N/A
N/A	Road 1 Slope (%)	3.8	N/A	DWS 1 Full Width?	N/A
N/A	Road 1 X Slope (%)	3.0	N/A	DWS 1 Offset (In)	N/A
Yes	Refuge 2 Length (In)	36.0	N/A	Gutter 2 Ponding?	N/A
Yes	Refuge 2 Width (In)	119.0	N/A	Gutter 2 Lip Ht (In)	N/A
Yes	Refuge 2 Slope (%)	2.2	N/A	Gutter 2 Slope (%)	N/A
No	Refuge 2 X Slope (%)	5.3	N/A	Gutter 2 X Slope (%)	N/A
N/A	Painted X Walk2?	No	N/A	DWS 2 Provided?	N/A
N/A	X Walk 2 Direction	To NW	N/A	DWS 2 Contrast?	N/A
N/A	X Walk 2 Width (In)	N/A	N/A	DWS 2 Length (In)	N/A

N/A	Road 2 Slope (%)	3.2	N/A	DWS 2 Full Width?	N/A
N/A	Road 2 X Slope (%)	2.7	N/A	DWS 2 Offset (In)	N/A
N/A	Refuge 3 Length (in)	N/A	N/A	Gutter 3 Ponding?	N/A
N/A	Refuge 3 Width (in)	N/A	N/A	Gutter 3 Lip Ht (in)	N/A
N/A	Refuge 3 Slope (%)	N/A	N/A	Gutter 3 Slope (%)	N/A
N/A	Refuge 3 XSlope (%)	N/A	N/A	Gutter 3 XSlope (%)	N/A
N/A	Painted X Walk3?	No	N/A	DWS 3 Provided?	N/A
N/A	X Walk 3 Direction	N/A	N/A	DWS 3 Contrast?	N/A
N/A	X Walk 3 Width (in)	N/A	N/A	DWS 3 Length (in)	N/A
N/A	Road 3 Slope (%)	N/A	N/A	DWS 3 Full Width?	N/A
N/A	Road 3 XSlope (%)	N/A	N/A	DWS 3 Offset (in)	N/A
Yes	Any Obstructions?	N/A	N/A	Storm Grate/Utility Hazard?	N/A
N/A	Obstruction Type		N/A	Storm Grate/Utility Type	
		N/A			N/A
N/A	Surface Condition	Good

**Remove & Replace Entire Refuge.**

**\$ 3000.00**
