# Access Compliance Report

## Public Rights-of-Way

### (Island Curb Cuts)

| Intersection ID: 12640 | Main Street: W_MOREHEAD_ST | Cross Street: WILKINSON_BV | Location: NW |

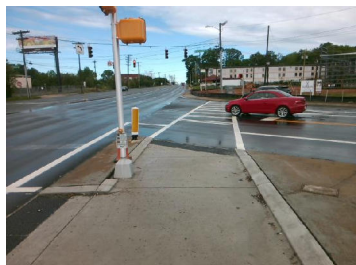
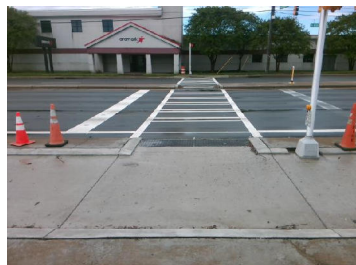
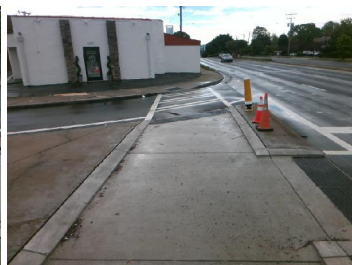
| Compliance | Description | Data | Compliance | Description | Data |
|---|---|---|---|---|---|
| N/A | Road 3 XSlope (%) | 1.9 | No | DWS 3 Offset (in) | 2.5 |

**Remove & Replace Detectable Warning System.**
