Access Compliance Report

Public Rights-of-Way

(Island Curb Cuts)

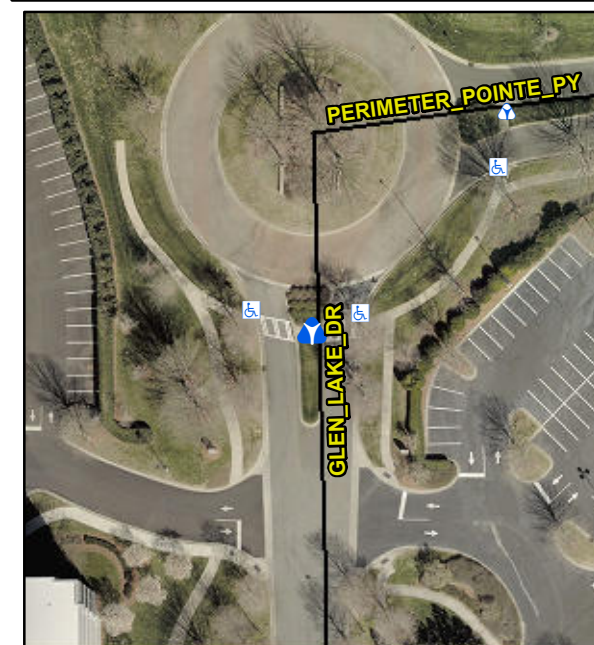
Intersection ID: 10027256	Main Street: GLEN_LAKE_DR	Cross Street: N/A	Location: S
ADA ID: B38383AF1725	Curb Cut Type: MedianRefuge2	Initial Pass/Fail: Fail	Overall Compliance: No
Severity Score: 1.25			
Codes/Mitigation Info/Possible Solution		Field Measurements/Component Compliance

Compliance	Description	Data	Compliance	Description	Data
Yes	Refuge 1 Length (In)	79.5	N/A	Gutter 1 Ponding?	N/A
Yes	Refuge 1 Width (In)	60.0	N/A	Gutter 1 Lip Ht (In)	N/A
Yes	Refuge 1 Slope (%)	4.8	N/A	Gutter 1 Slope (%)	N/A
Yes	Refuge 1 X Slope (%)	1.4	N/A	Gutter 1 X Slope (%)	N/A
N/A	Painted X Walk1?	Yes	N/A	DWS 1 Provided?	N/A
N/A	X Walk 1 Direction	To W	N/A	DWS 1 Contrast?	N/A
N/A	X Walk 1 Width (In)	104.0	N/A	DWS 1 Length (In)	N/A
N/A	Road 1 Slope (%)	3.3	N/A	DWS 1 Full Width?	N/A
N/A	Road 1 X Slope (%)	2.6	N/A	DWS 1 Offset (In)	N/A
Yes	Refuge 2 Length (In)	79.5	N/A	Gutter 2 Ponding?	N/A
Yes	Refuge 2 Width (In)	60.0	N/A	Gutter 2 Lip Ht (In)	N/A
Yes	Refuge 2 Slope (%)	0.4	N/A	Gutter 2 Slope (%)	N/A
Yes	Refuge 2 X Slope (%)	2.3	N/A	Gutter 2 X Slope (%)	N/A
N/A	Painted X Walk2?	Yes	N/A	DWS 2 Provided?	N/A
N/A	X Walk 2 Direction	To E	N/A	DWS 2 Contrast?	N/A
N/A	X Walk 2 Width (In)	104.0	N/A	DWS 2 Length (In)	N/A

N/A	Road 2 Slope (%)	3.1	N/A	DWS 2 Full Width?	N/A
N/A	Road 2 X Slope (%)	0.2	N/A	DWS 2 Offset (In)	N/A
N/A	Refuge 3 Length (in)	N/A	N/A	Gutter 3 Ponding?	N/A
N/A	Refuge 3 Width (in)	N/A	N/A	Gutter 3 Lip Ht (in)	N/A
N/A	Refuge 3 Slope (%)	N/A	N/A	Gutter 3 Slope (%)	N/A
N/A	Refuge 3 XSlope (%)	N/A	N/A	Gutter 3 XSlope (%)	N/A
N/A	Painted X Walk3?	N/A	N/A	DWS 3 Provided?	N/A
N/A	X Walk 3 Direction	N/A	N/A	DWS 3 Contrast?	N/A
N/A	X Walk 3 Width (in)	N/A	N/A	DWS 3 Length (in)	N/A
N/A	Road 3 Slope (%)	N/A	N/A	DWS 3 Full Width?	N/A
N/A	Road 3 XSlope (%)	N/A	N/A	DWS 3 Offset (in)	N/A
Yes	Any Obstructions?	N/A	N/A	Storm Grate/Utility Hazard?	N/A
N/A	Obstruction Type		N/A	Storm Grate/Utility Type	
		N/A			N/A
N/A	Surface Condition	Good

Possible Solutions:

Remove & Replace Entire Refuge.
